Highway Accident Report - Multiple
Vehicle Collisions and Fire, Caldecott
Tunnel Near Oakland, California, April 7, 1982

(U.S.) National Transportation Safety Board
Washington, DC

1. Report No. NTSB/HAR-83/01		2. Government Accession No. PB83-916201		3. Recipient's Catalog No.	
4. Title and Subtitle Multiple Vehicle Collisions and Fire Caldecott Tunnel, Near Oakland, California, April 7, 1982.		5. Report Date May 3, 1983		6. Performing Organization Code

**MULTIPLE VEHICLE COLLISIONS AND FIRE
CALDECOTT TUNNEL
NEAR OAKLAND, CALIFORNIA
APRIL 7, 1982**

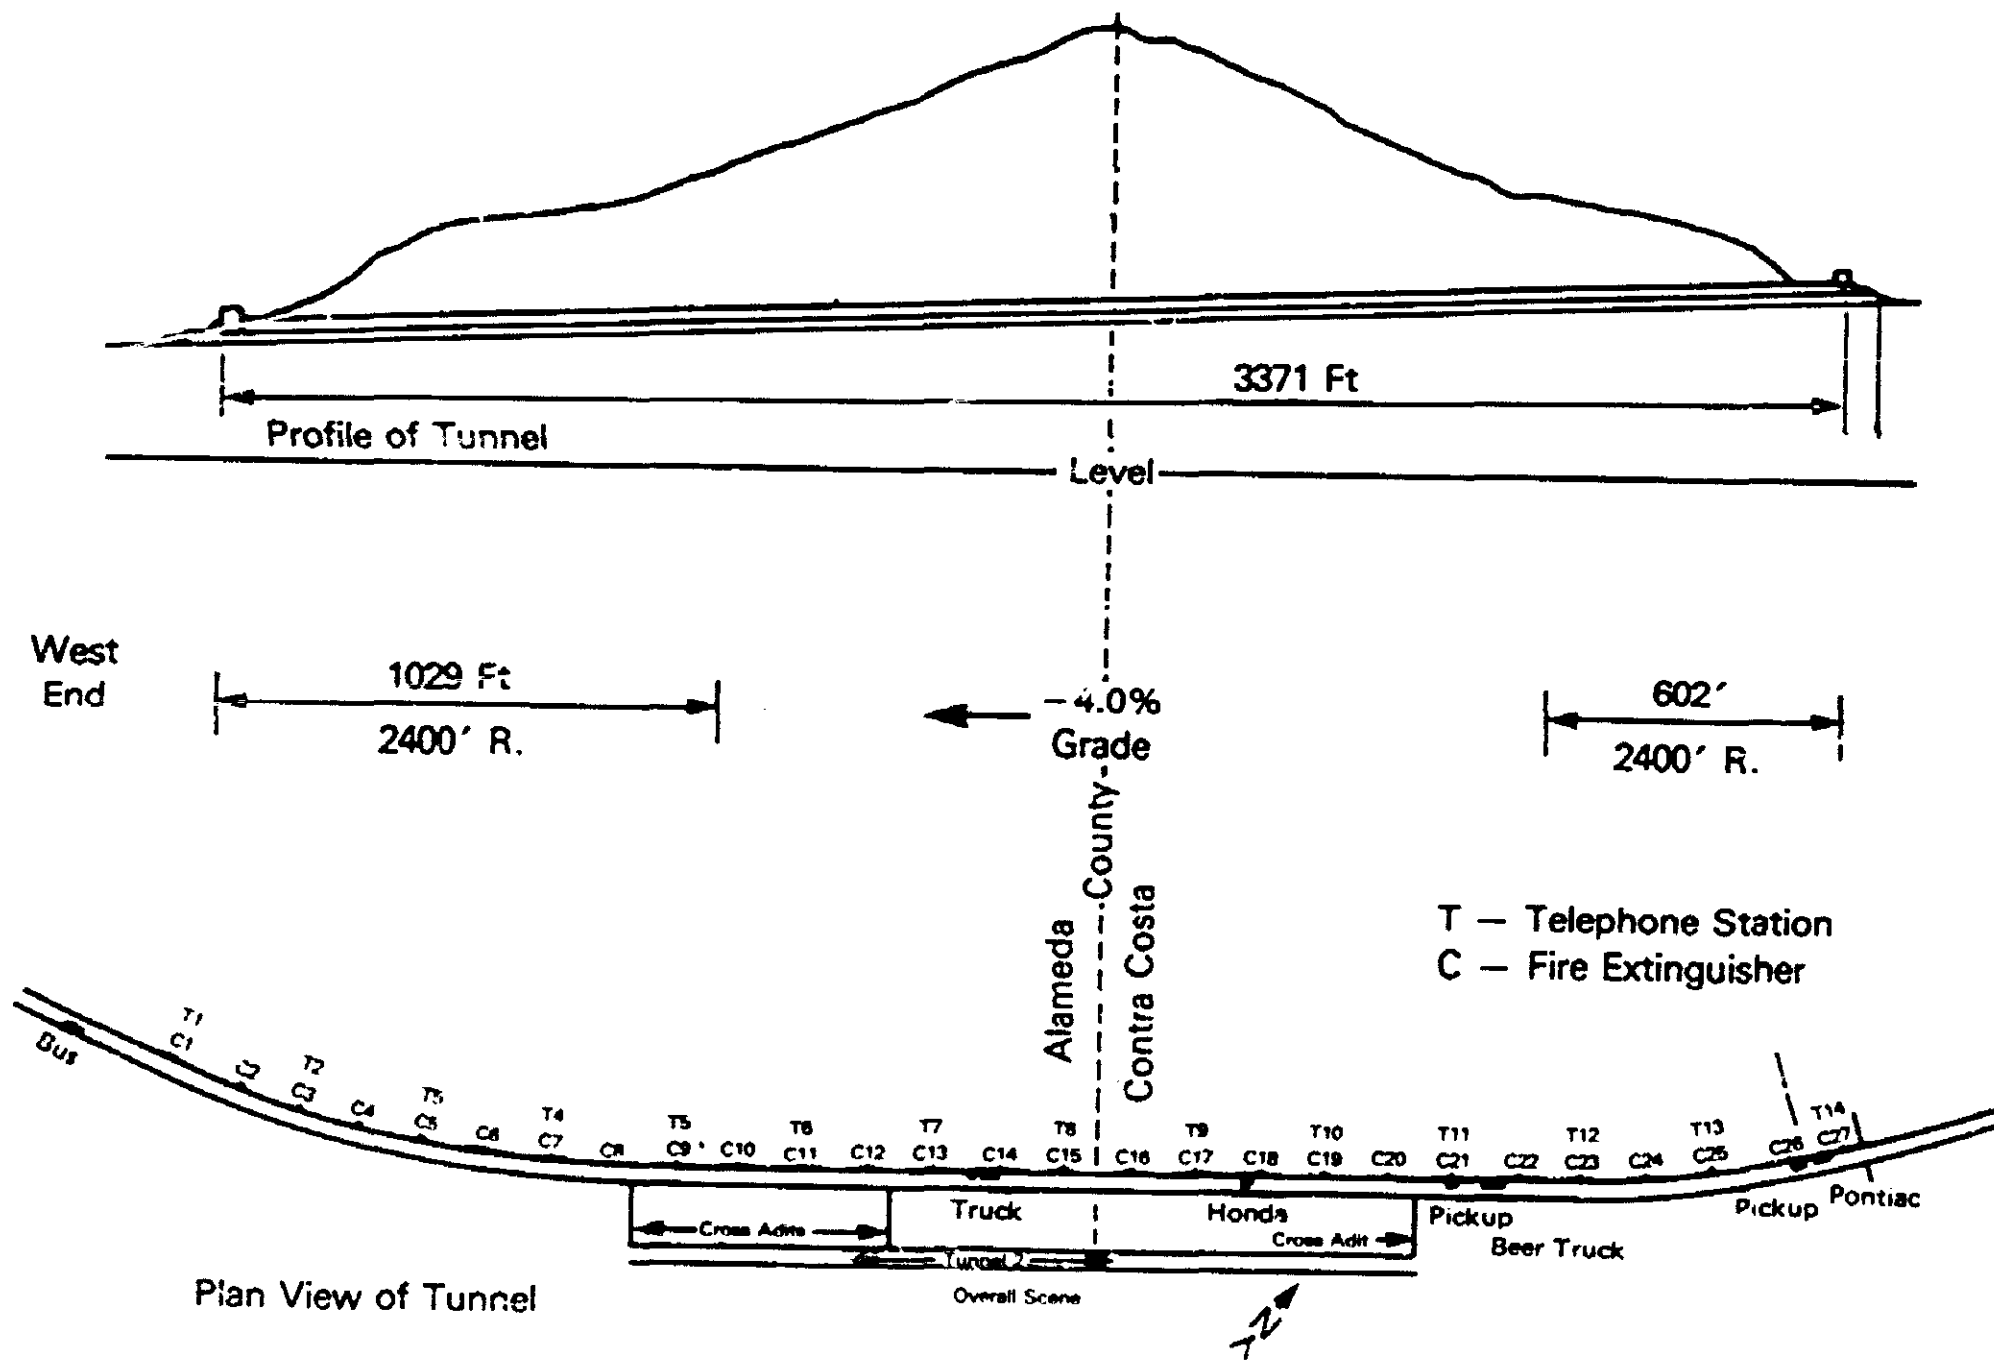
Figure 2.—Plan and profile of California State Route 24 through the Caldecott Tunnel. (Final resting positions of vehicles.)

Shortly thereafter, as the motorists to the rear of the beer truck awaited their turn to back out, they observed that "thick black smoke appeared to be coming up from the road and moving rapidly toward them." Some of the motorists reported that as they were trying to escape, they observed the passage of two walls or "waves" of smoke and heat. The first "wave" of smoke reached the motorists when they were within 200 to 250 feet of the rear of the beer truck. They rolled up their windows and started to back their vehicles as fast as they could. Before all of the motorists had backed out of the tunnel, a second heavy concentration of black, hot smoke overtook them and they had difficulty seeing and breathing. The motorists said that the second "wave" was darker, thicker, and hotter than the first wave. The thick smoke overtook the Ford pickup truck driver as he was walking eastward, and he was unable to get back to his mother who was using the phone. Another driver, who had backed his Toyota pickup truck until it was stopped by a Pontiac car that was turned around in the roadway, found it necessary to abandon his vehicle, grope through the smoke to the wall, and feel his way out of the tunnel. The two occupants of the Pontiac stayed in their car. As the thick black smoke from the second "wave" reached the end of the tunnel, the smoke went straight up in the air. There were "loud explosions," the lights went out, and the tiles started falling from the walls and ceiling of the tunnel. Motorists reported that the intense heat and smoke prevented any of the onlookers at the east portal from returning inside and rescuing any of the trapped motorists. Meanwhile, the tank truck driver had run from his truck out of the west end of the tunnel. (See figure 2 for vehicle rest positions.)

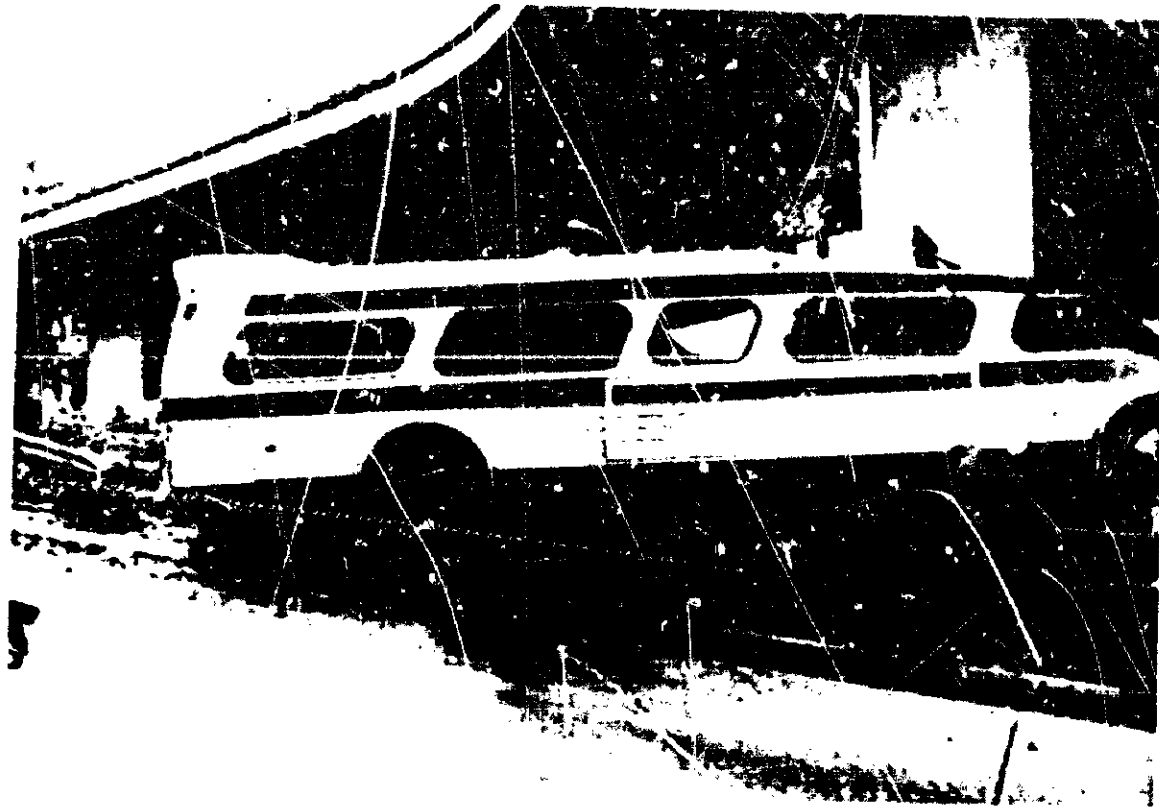
Figure 5.—AC Transit bus after impact.

AC Transit bus--The force of the collision of the bus with the structural pier caused a 17-foot rearward displacement of the center front components. (See figure 5.) As a result of a 24-inch-wide area of penetration along the longitudinal center of the bus (see figure 8), passenger seats were rotated and pushed outward and the plywood floor was completely destroyed. The center of the front axle beam was bent approximately 6 inches rearward with axle and suspension attachment devices displaced and destroyed. Top-mounted identification lamps and the sheet metal located below the windshield were pushed 17 feet rearward. Both ends of the front bumper were deformed rearward, and the bumper was separated at the center. Lateral rubber markings measuring 10 inches and 4 inches were located on the bottom forward face of the bumper at the right end and left end, respectively.

The busdriver's ejection from the bus at the time of collision with either the Honda or the tank trailer indicated that he was not utilizing the lap restraint that was available at his seat. The bus continued towards the left, climbed the curb, and the left front wheel lugs and side mirror contacted the tunnel wall intermittently until the bus exited the tunnel. Initial contact with the "W" beam guardrail outside of the tunnel damaged the bus' left side. The bus penetrated the guardrail and impacted a highway support pier, which deformed front end components 17 feet rearward. (See figure 5.)

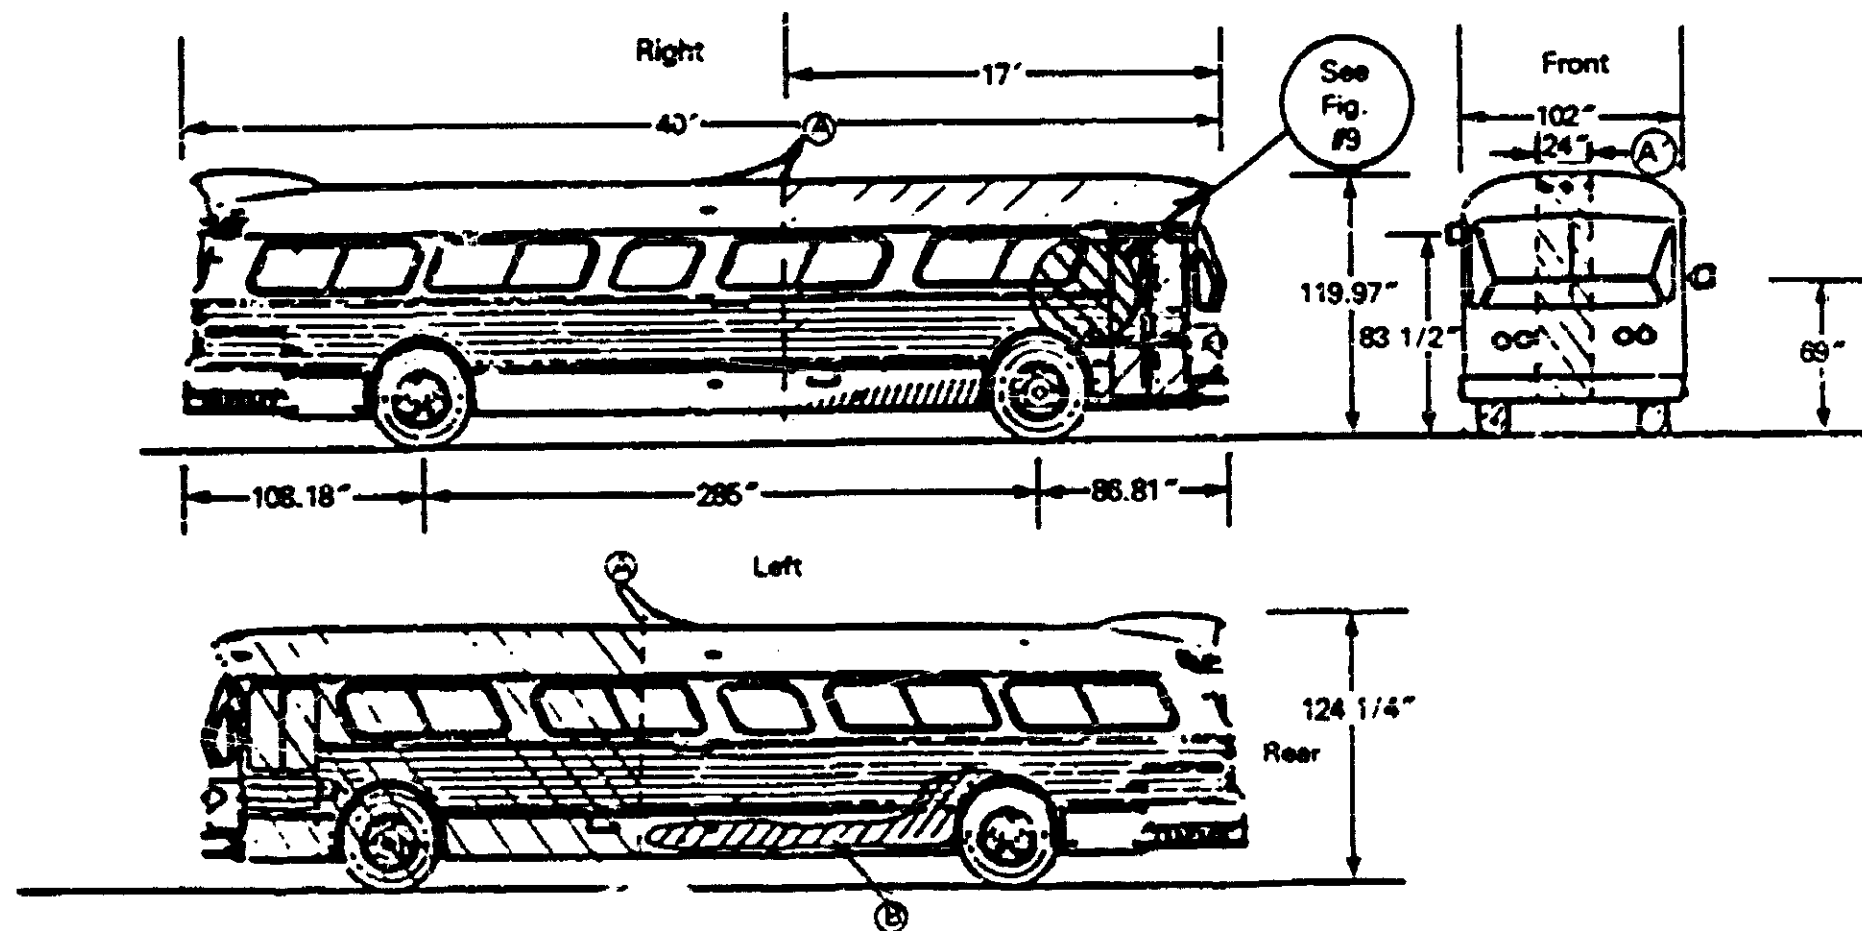
Figure 8.—Sketch of AC Transit bus with impact damage illustrated.

There was no sheet metal sideswipe damage at the forward left corner of the bus. (See figure 8.) The outer projections of the disc wheel lugs on the left front wheel were ground down.

There was a horizontal scratch pattern on the left side from the rear wheelwell to approximately the midpoint of the distance between the axles. Scratches were found 22, 25, and 28 inches above the ground. There were black marks approximately 18 inches long and 22 inches above the ground, directly forward of the rear wheelwell. The trim at the forward edge of the rear wheelwell was kinked and deformed rearward 29 1/2 inches above the ground.

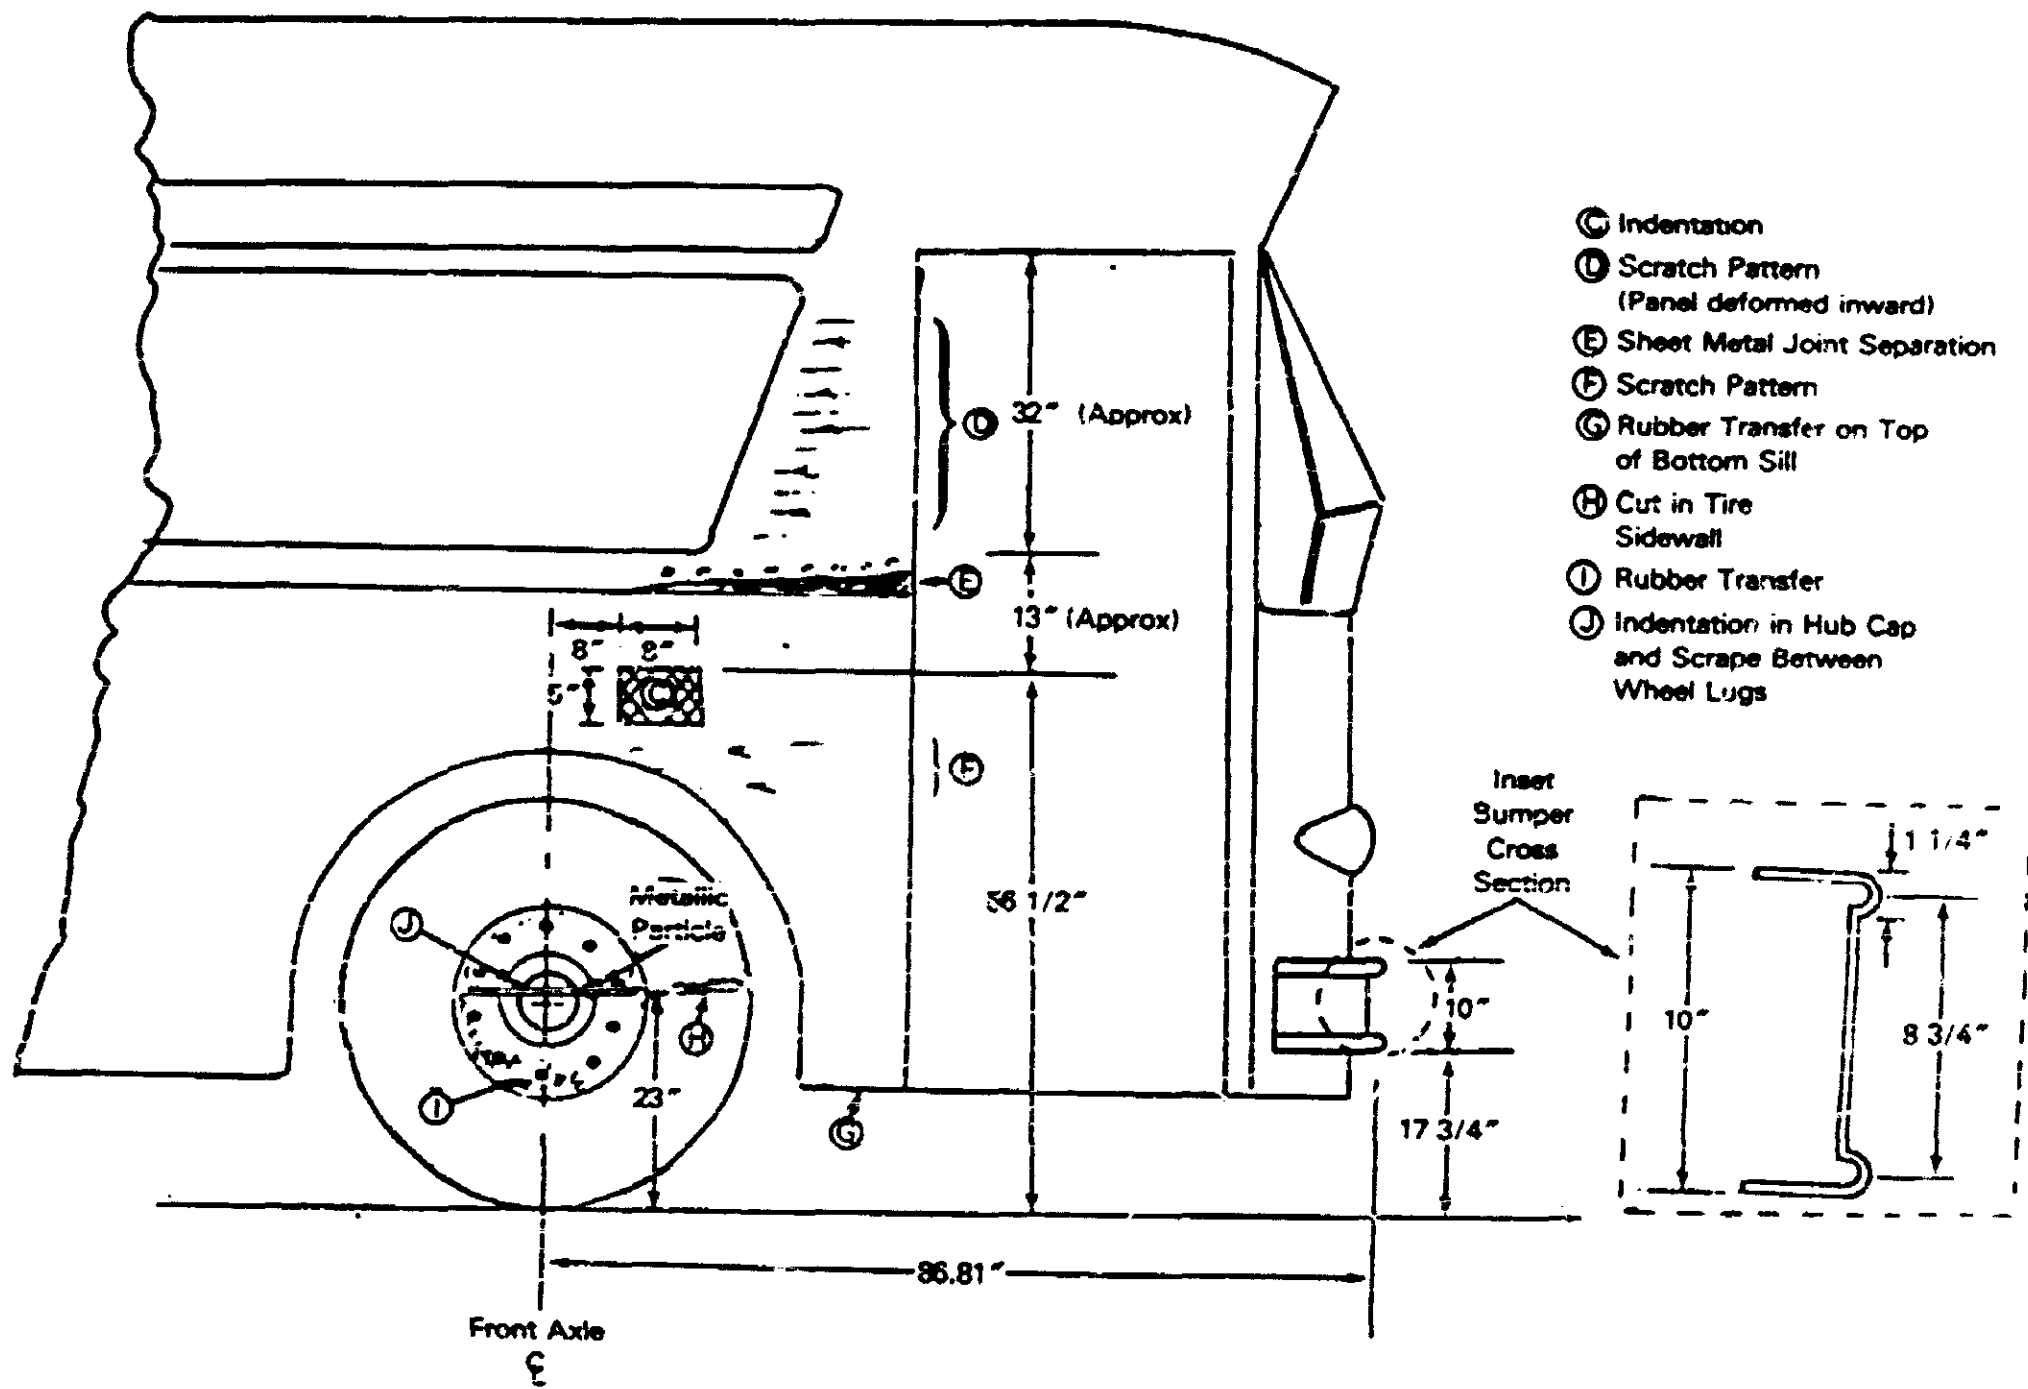
Figure 9.—Sketch illustrating right front end components of AC Transit Bus.

A cut was found in the sidewall of the right front tire and was in alignment with a wheel abrasion mark and hubcap dent (item J, figure 9). Rubber deposits were found on the outer face of the disc wheel in the wheel lug bolt circle area.

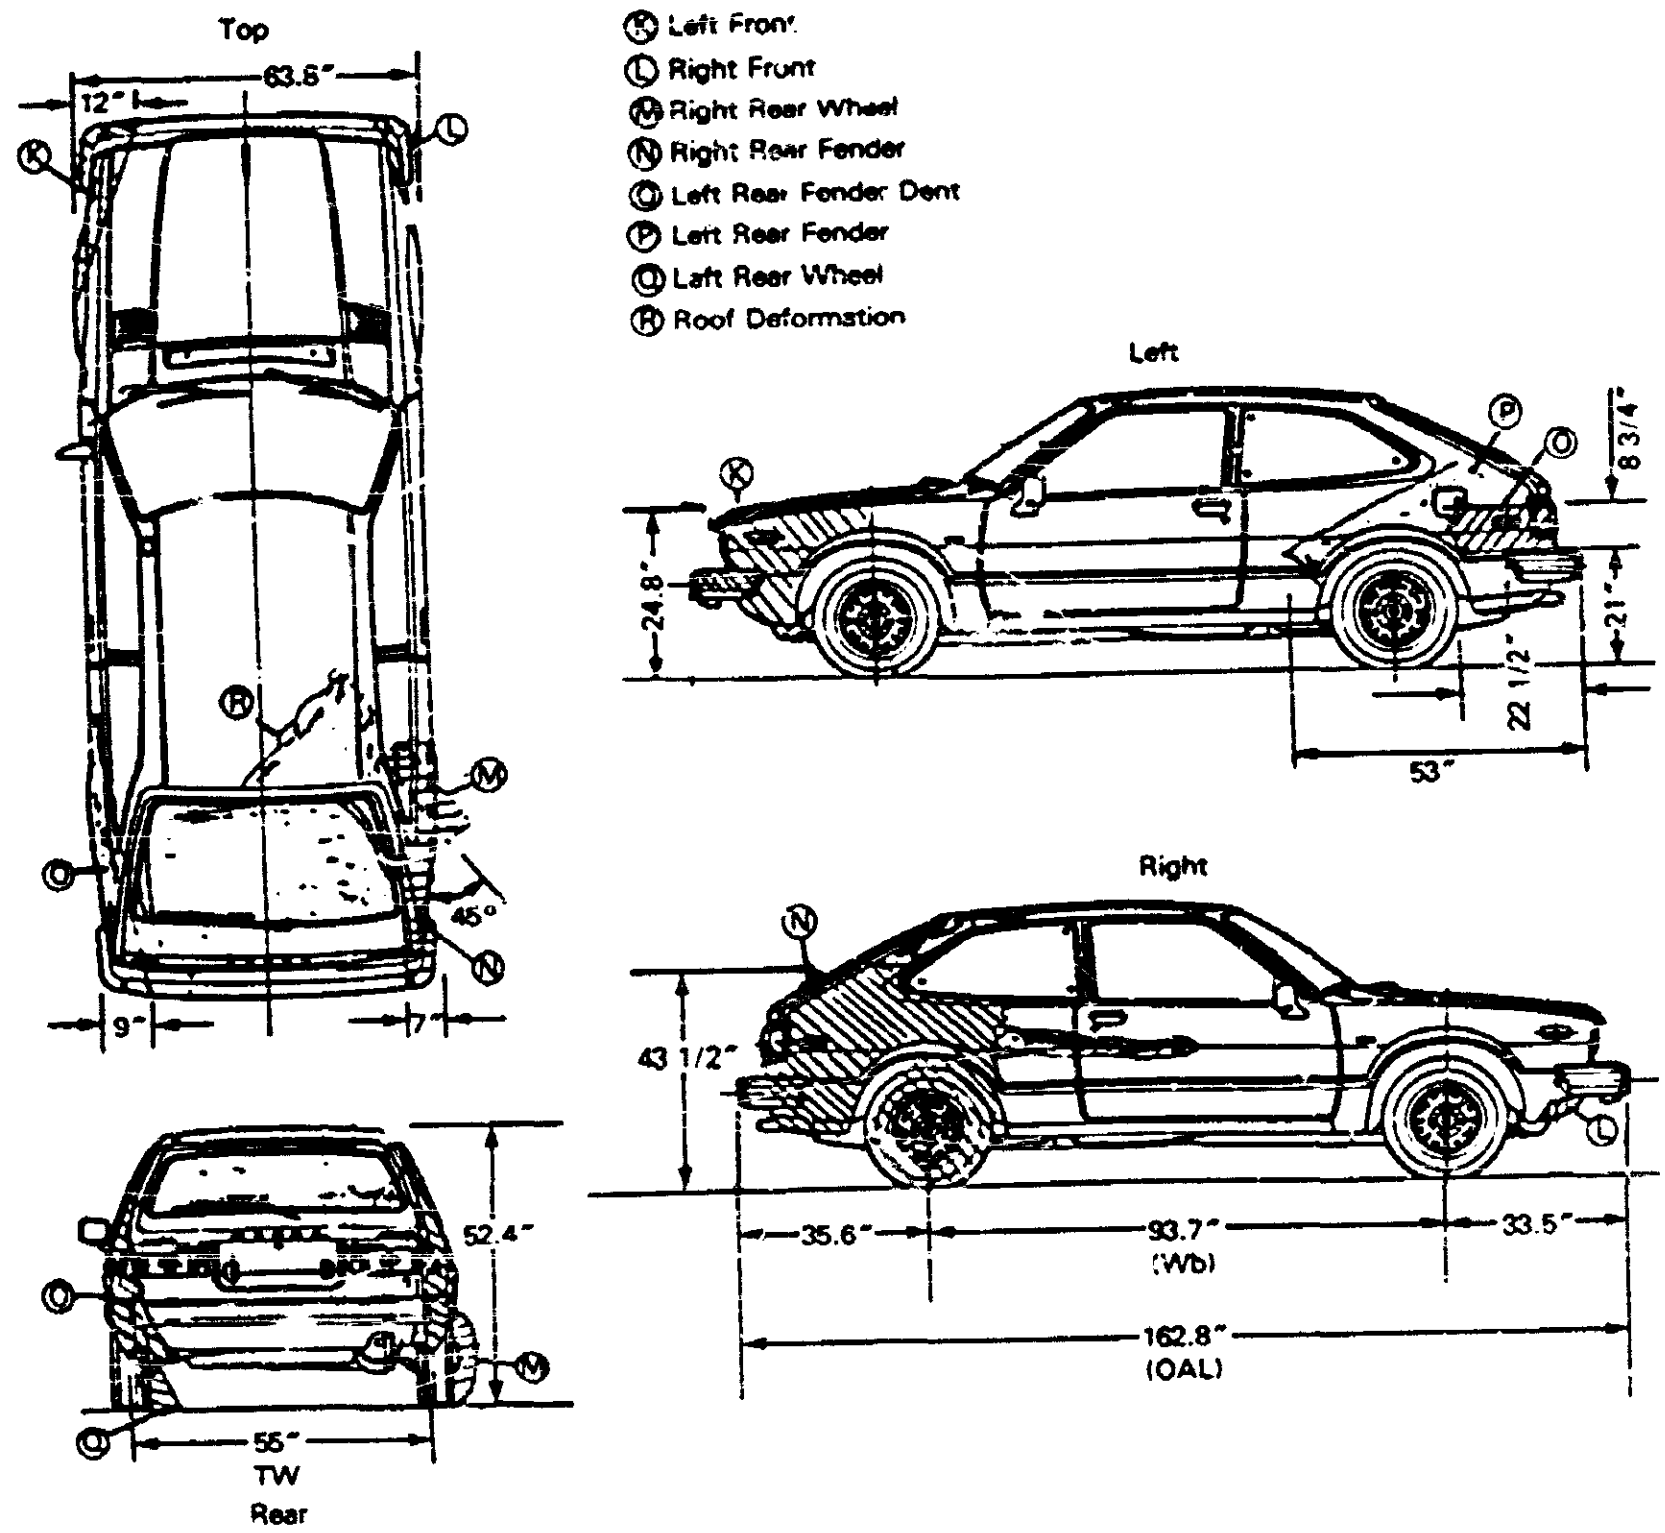
Figure 11.—Areas of damage to 1978 Honda.

The Honda Accord.---The Honda Accord was found 1,196 feet west of the east portal at a 45° angle to the roadway, with the right front wheel against the north (right) curb. All combustible and low melting point materials had been consumed by fire. (See figures 6 and 7.) All four corners, both rear wheel suspensions, and the right rear roof quadrant had been deformed by impact.

The right rear hatchback post and rain gutter were deformed inward up to a point 43 1/2 inches above the road. The upper half of the hatchback side window post was deformed inward at a greater attitude than the lower half. The roof (item R, figure 11) had been deformed slightly downward and had also incurred heat damage. The right rear wheel (item M, figure 11) had been pushed forward and deformed with the front toed inward at a 45° angle. The rectangular-shaped damage to the left rear fender (item O, figure 11) was 8 3/4 inches long in the vertical direction and 22 1/2 inches from the rear bumper. The entire left rear fender (item P, figure 11) and a portion of the rear panel below the bumper was dented. The bottom of the left wheel (item Q, figure 11) was toed inward.

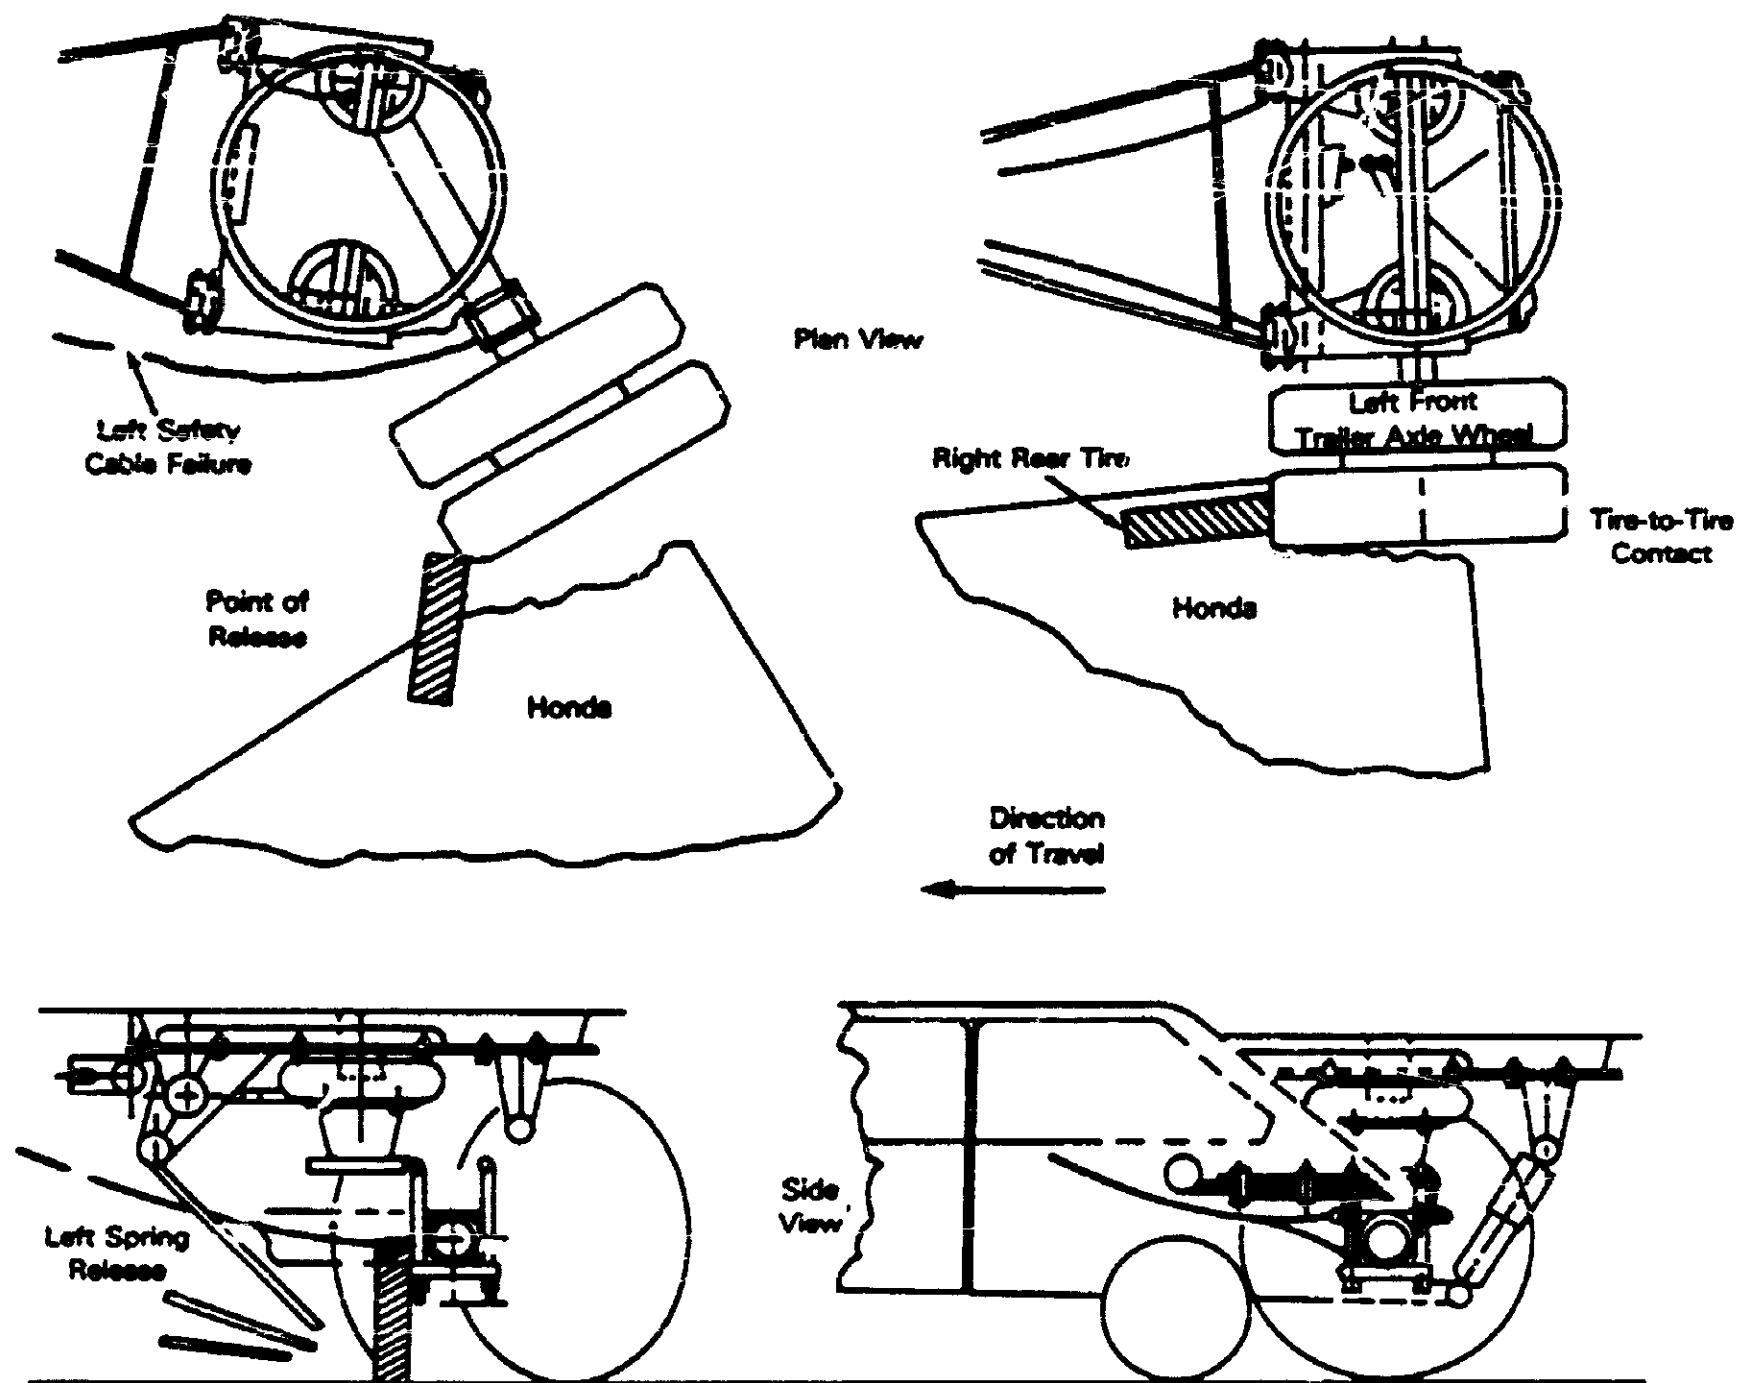
Figure 16.--Front trailer axle interaction with Honda right rear.

The damage to the tank truck and Honda indicated that the major impact between the tank truck and the Honda occurred when the left front tire of the tank trailer struck the right rear corner of the Honda (see figure 16). This impact drove the right side of the Honda rear bumper downward, the sheet metal forward, the right rear wheel forward in the wheel well, squeezed the Honda against the left curb, and displaced the left rear wheel inward (see figure 7). As a result of the impact, the left front suspension of the tank trailer was separated rearward from the trailer chassis, and the left side of the Honda then impacted the tunnel wall, increasing the damage at the left front (see figure 10), and also damaging the left side at the rear.

The truckdriver does not recall a collision between his vehicle and the Honda. Based on the impact damage, the Board believes that the tank trailer did collide with the Honda, and that, perhaps, given the difference in mass between his truck and the Honda and the immediacy of the subsequent collision with the bus, the truckdriver may not have been aware of the collision with the Honda.
