SANDIA REPORT

SAND88-2902 • UC-70

Analysis of the Accidental Explosion at Pepcon, Henderson, Nevada, May 4, 1988

Jack W. Reed

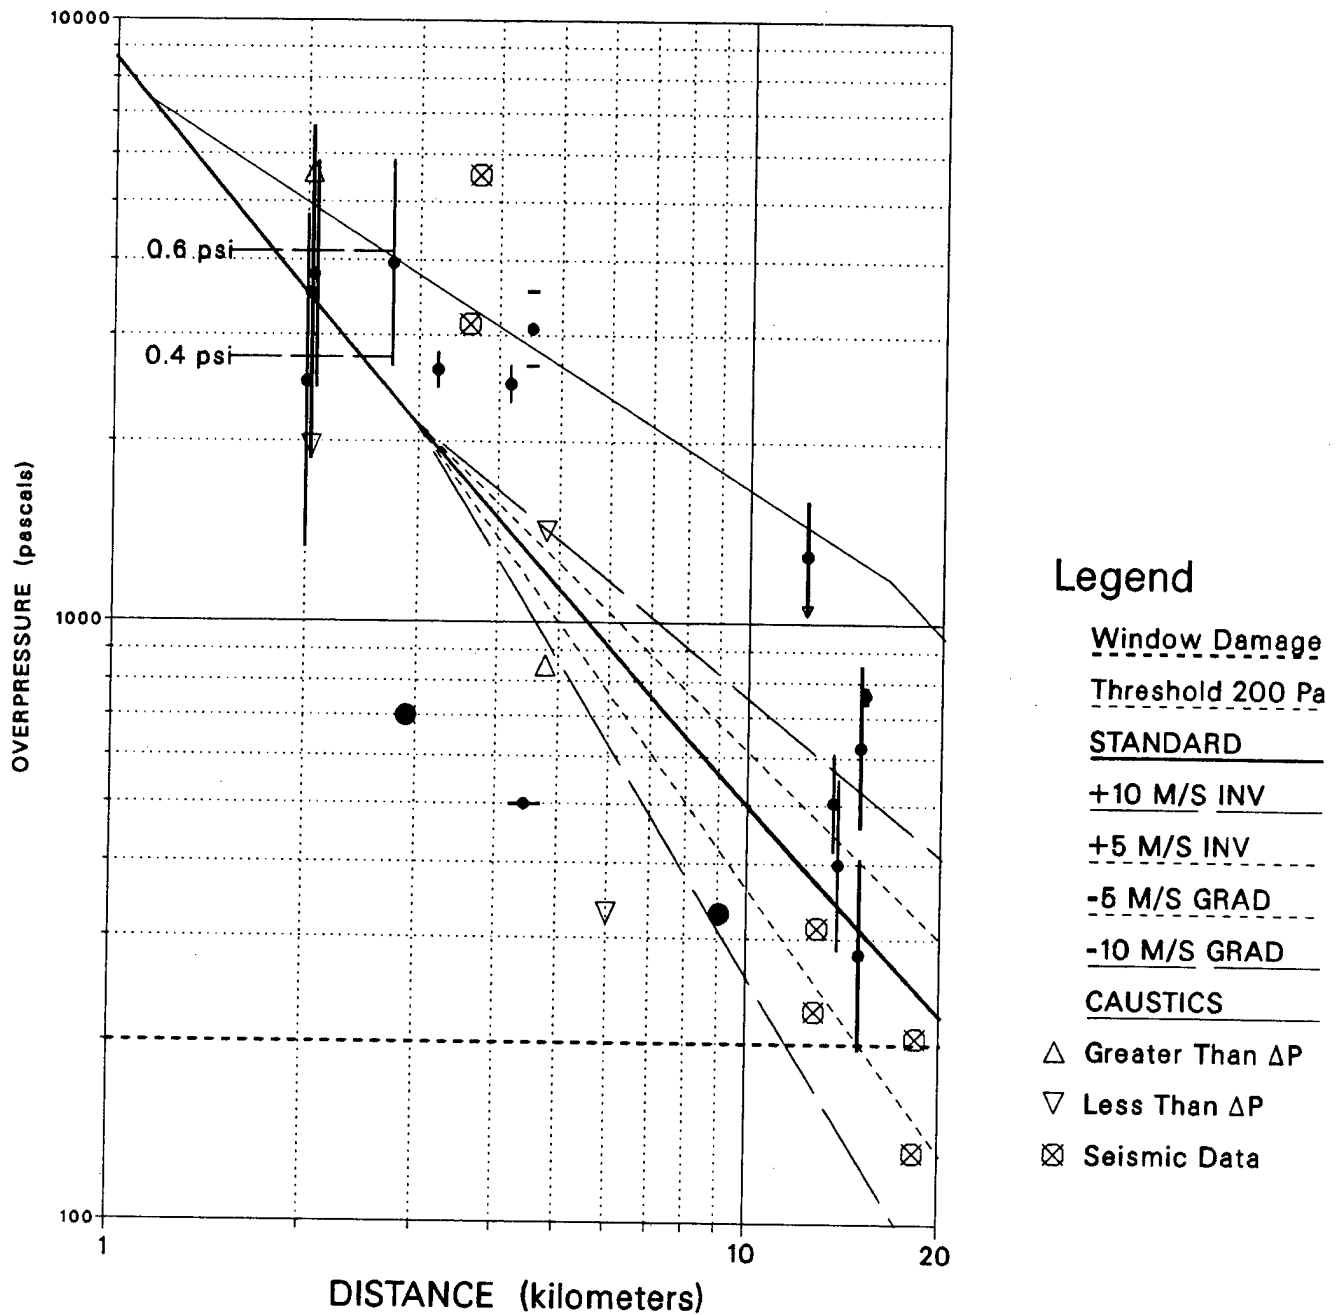
Figure 10. Airblast overpressure versus distance curves for 250-ton TNT surface burst at PEPCON, with data estimated from damage evaluations. (Vertical bars indicate range of overpressures needed to give observed damage probabilities).

Notes from a two-day survey of damages in Henderson and Las Vegas have been included in Appendix A. Since TTU surveyors reported considerable detail on their tape recorders, only relatively few, seemingly striking or important features were written down by this author. These have been interpreted, through use of Figures 5 through 8, as estimated overpressure-distance values shown in Figure 10. Interpretive details are listed in Tables 9 and 10.

In summary of these spot damage interpretations in Figure 10, the cloud of data does generally surround a 1-kt NE Standard curve, reinforcing the initial estimate that the largest PEPCON explosion was about equivalent to 250 tons, possibly 500 tons, of chemical high explosives. But ammonium perchlorate is "not detonable", so there are no federal, state, or OSHA standards for treating and handling it as such, nor TNT equivalences for estimating how much AP actually exploded.

Other window damage observations, to 15-km distances, generally scattered around a 1-kt NE overpressure-distance curve, with random deviations caused by turbulent atmospheric details, well-known large scatter in glass plate failure characteristics, pane orientation and blast reflecting variations variations, as well as window installation details and the local environment of building reflectors, refractors, and diffractors. Many further damage measurements were made but not yet analyzed. They may provide some refinement to an overpressure pattern and increased confidence in final conclusions.

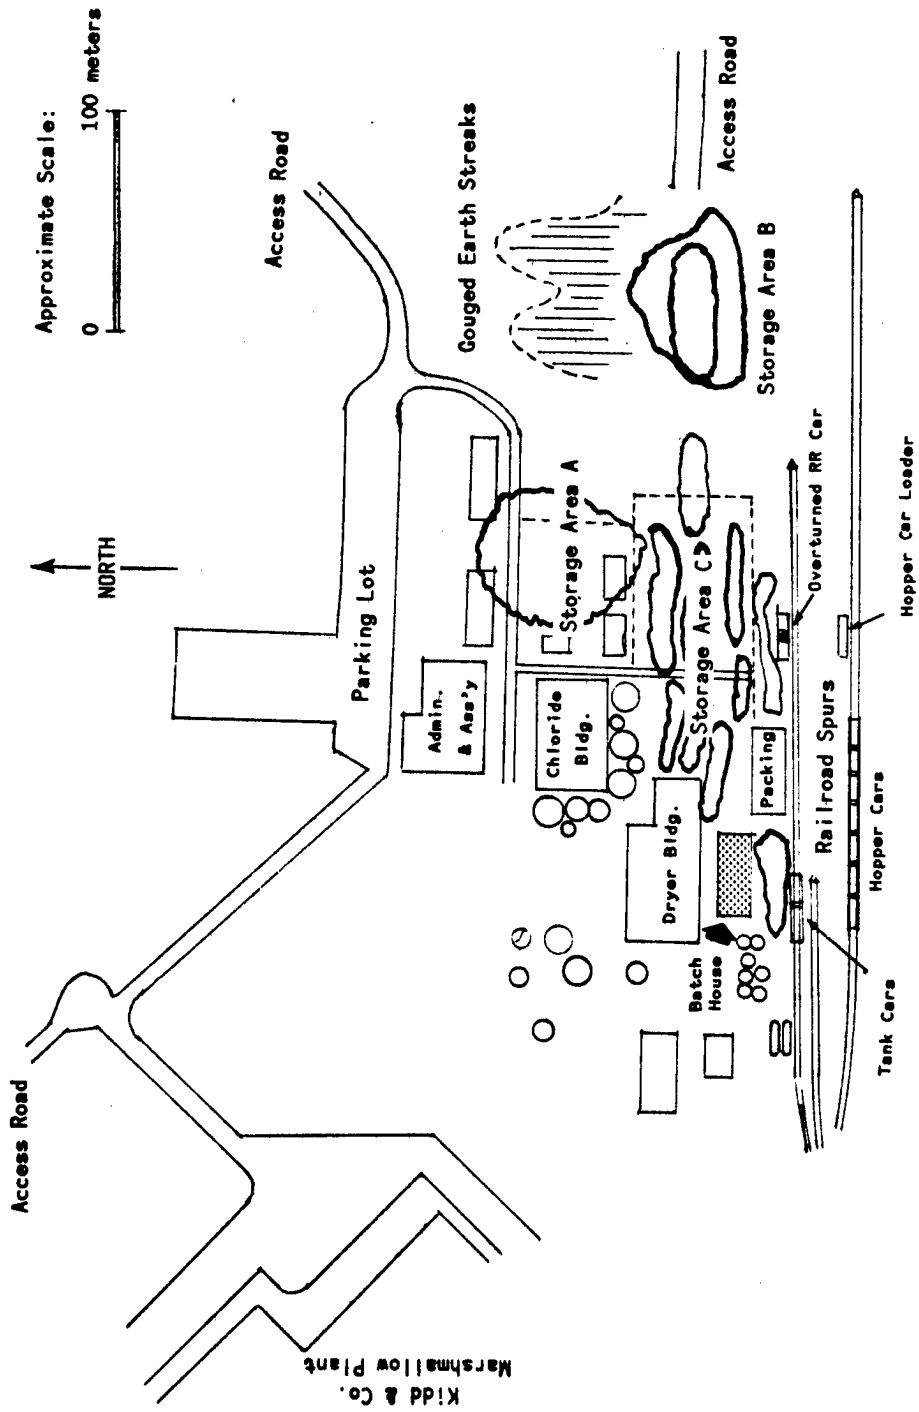
Figure 12. Sketch map of Pacific Engineering Company (PEPCON), Henderson, Nevada, with primary explosion damage features.

Aerial photography was flown over the PEPCON region by EG&G, instrumentation contractors to DOE-NVO, on May 10, 1988. The expectation was that an explosion crater could be dimensioned as an additional yield estimator. Since there was no clear crater formation comparable to ones observed after point explosion tests, no yield scaling was possible. Their photographs did assist in estimating what happened, however, as well as help clear up some map scaling problems that were encountered in connecting the Henderson map in Figure 9 to the Las Vegas map in Figure 11. A sketch of the PEPCON facility in Figure 12, annotated with help from newspaper stories in Appendix B, shows where the initial fire broke out of control in the Batch House, then spread to the Dryer Building and on to the Chloride Building. It is not clear where the first large explosion occurred. What is obvious from these aerial photographs is that the latest and largest explosion occurred in Storage Yard B, nearly 300 m east of the Batch House.

Although it is not important to analysis of damage, overwhelmingly caused by the largest explosion, it might appear that the first explosion occurred at the Batch House and a small adjacent storage area. The east end of the Batch House appears to have been blown away. The second, dark explosion could have been a relatively low-order detonation of the 607-Mg AP in Storage Area A.

Aerial photographs of the destroyed PEPCON plant and vicinity have allowed a reconciliation between available maps of Henderson and Las Vegas so that sufficiently accurate estimates of distances to various damage sites could be made. Also, they gave a fairly certain location for the largest explosion, in Storage Area B, which accounted for most of the damages. Information on the amounts of
