# **A Forensic Investigation Of The Breakup And Sinking Of The Great Lakes Iron Ore Carrier *Edmund Fitzgerald*, November 10th 1975, Using Modern Naval Architecture Tools And Techniques**

**Sean Kery, CSC Advanced Marine Center, Washington, DC  
Ben Fisher, SAFE Boats International, Bremerton, Washington**

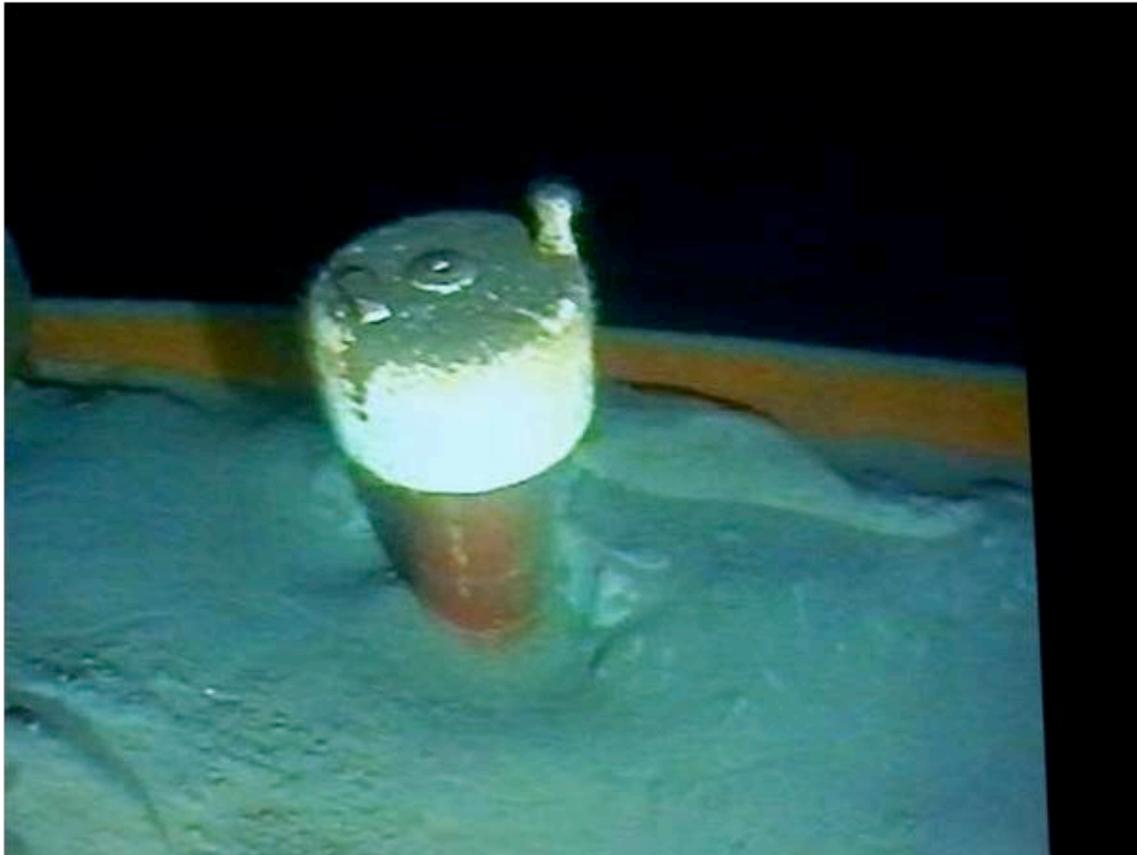
Figure 2: Typical 30 inch Tall Deck Vent Leading into the Tunnels. Source Bob Wasalawski

At around 1530 on November 10, McSorley radioed Cooper to inform him that the *Fitzgerald* had taken damage and “had a list”. The ship had lost two of the deck vents used as ventilation for the ballast tanks and under-deck tunnel, and also had lost a section of the “fence rail” that was a wire rope handrail that ran along both sides of the weather or spar deck. The cause and additional extent of this damage remains unknown, along with the exact location of the vessel when the damage occurred. The *Anderson* asked the *Fitzgerald* if the pumps were going and the reply was “Yes both of them”. This indicates that water was already coming in somewhere, although how much and where remain unknown. That the pumps were going also suggests that the list was not so bad that the water was prevented from reaching the pump intake plumbing on the centerline.

- Captain McSorley mentioned that two vents had been lost or damaged. There is at least one damaged vent on the bow section of the wreck, located on the starboard side near hatches 4 and 5. This is very possibly one of the vents to which McSorley had referred.

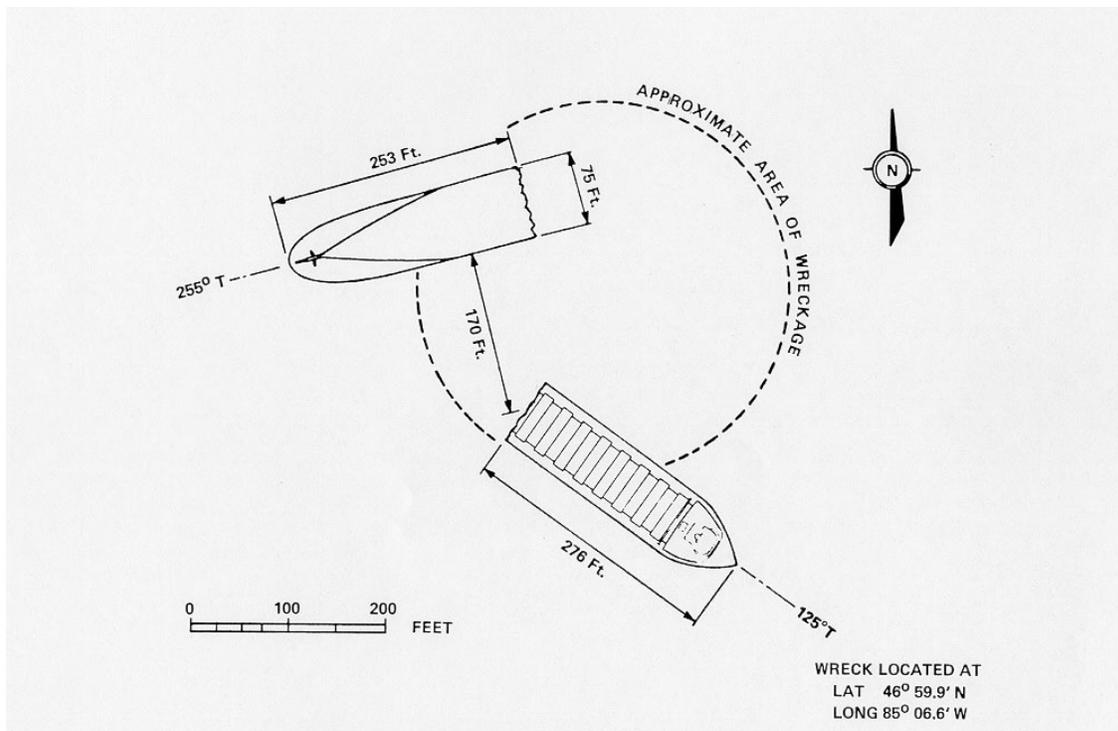
**Figure 5: Layout of *Edmund Fitzgerald* Wreckage Source: National Transportation Safety Board (1978)**

- Figure 5 shows that the stern location is not far past the location of the bow, which shows that the propeller and strong following winds did not continue to push on it for very long after the bow sank. If they had the separation would be significantly larger.

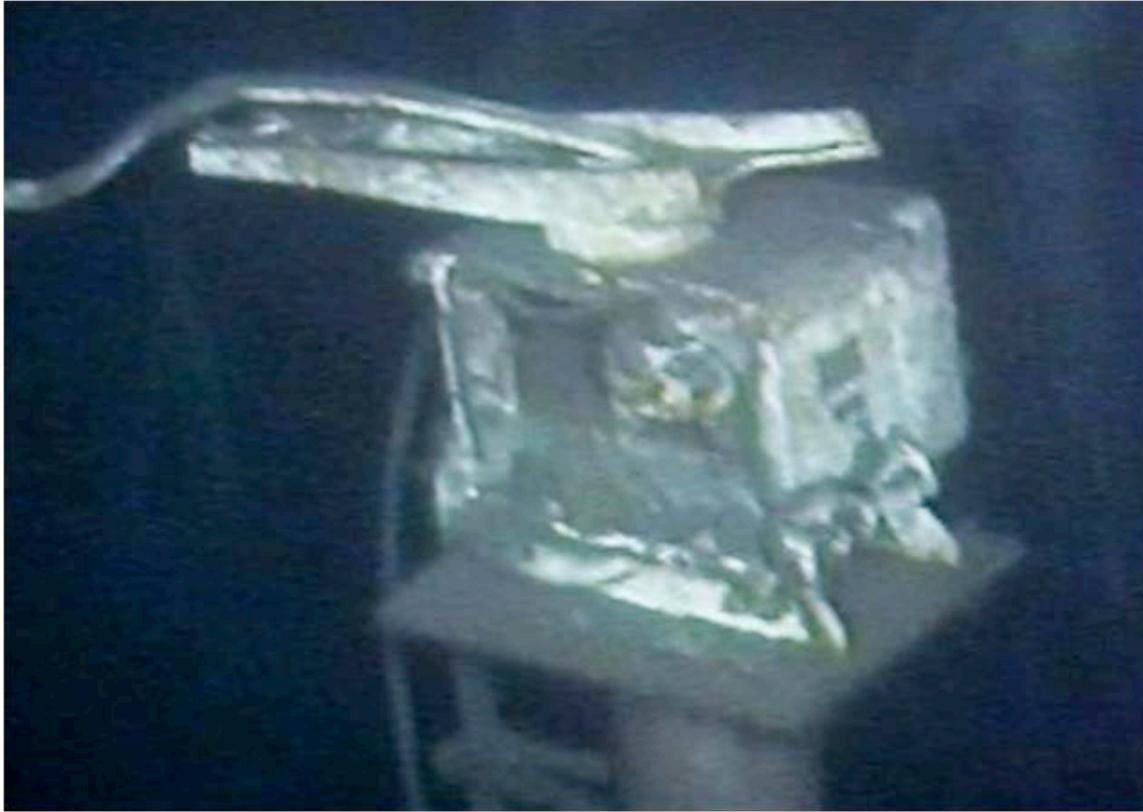
**Figure 6:**

The number one and number two hatch covers located directly behind the forward house are punched down inside the hold. The sun visor surrounding the top of the pilot house is mangled and severely bent downwards. The radar antenna located on the top of the forward house is broken. Figure 6. The fracture pattern is consistent with a large volume of wind-blown green water crashing down on it. Given the snowstorm, high winds and fresh water spray, the radar antenna and much of the superstructure could have been encased in ice. Severe icing would provide additional area for the green water to act on.

- The number 1 & 2 hatch covers were found within the hull of the bow section of the wreck. The hatch cover shows signs of exterior buckling, and the state of the hatch combing indicates hatch-cover buckling.

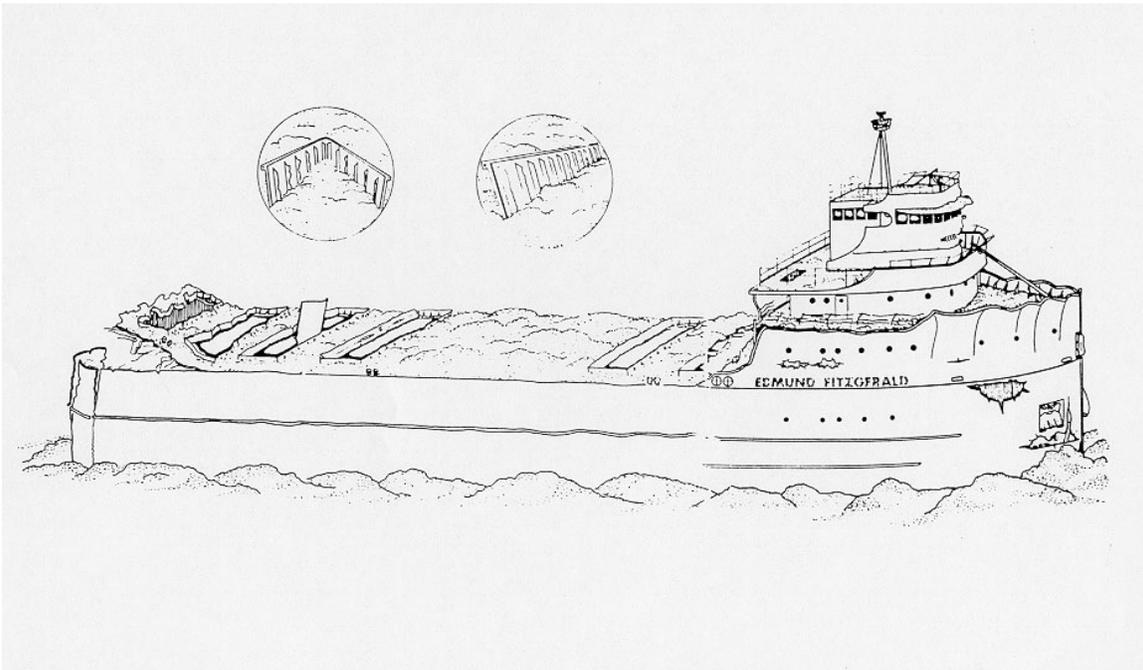
**Figure 7: Bow Section of Edmund Fitzgerald Wreck Source: National Transportation Board (1978)**

There is damage on the forward bow which is consistent with a possible hydrostatic implosion of a watertight compartment as the bow section descended in the water column. Much of the main deck is covered in a thick layer of taconite pellets. This indicates that the bow section reached the bottom before the cloud of taconite pellets that fell out of the various sections of the hold rained down around and on top of it.

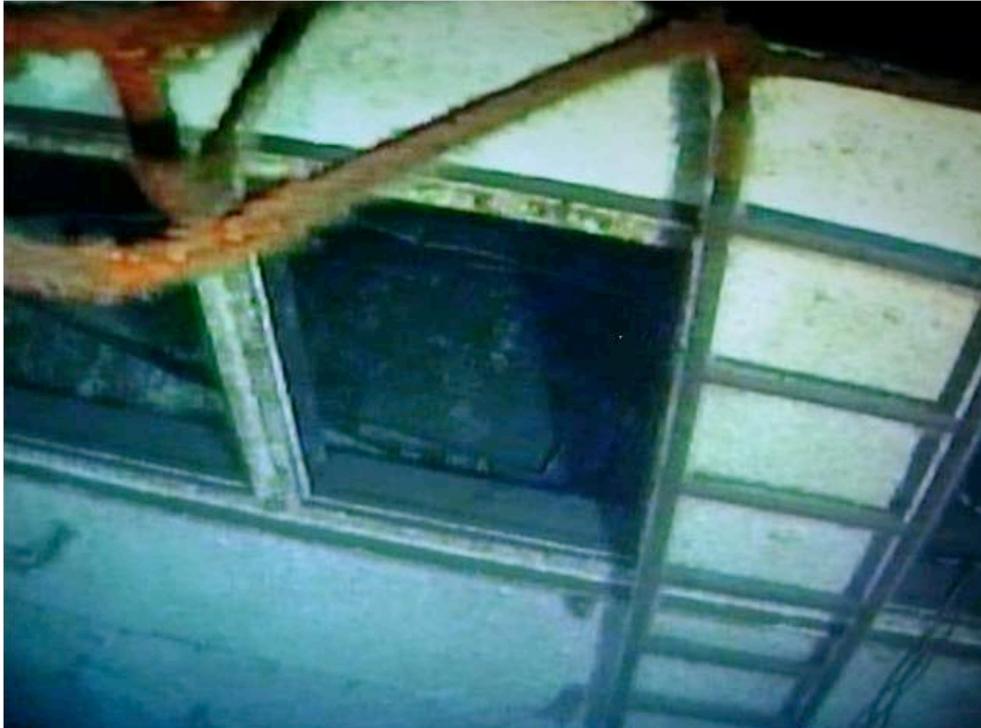
**Figure 8: Broken Rectangular Windows on Back of Forward House Source Bob Waslawski**

All but two of the rectangular windows on the back of the forward house have their glass blown inwards.

In the case of the *Edmund Fitzgerald* the forward house was probably not tall enough to provide for a complete reflection. Much of the water that splashed upwards backed by 50 mile per hour winds kept going until it crashed down, smashing down the sun visor on the front of the pilot house and tearing up the radar antennas. The wave slap from a breaking wave can exert thousands of pounds of force over an area the size of the rectangular windows on the back of the house, so it is not surprising that they were blown in.

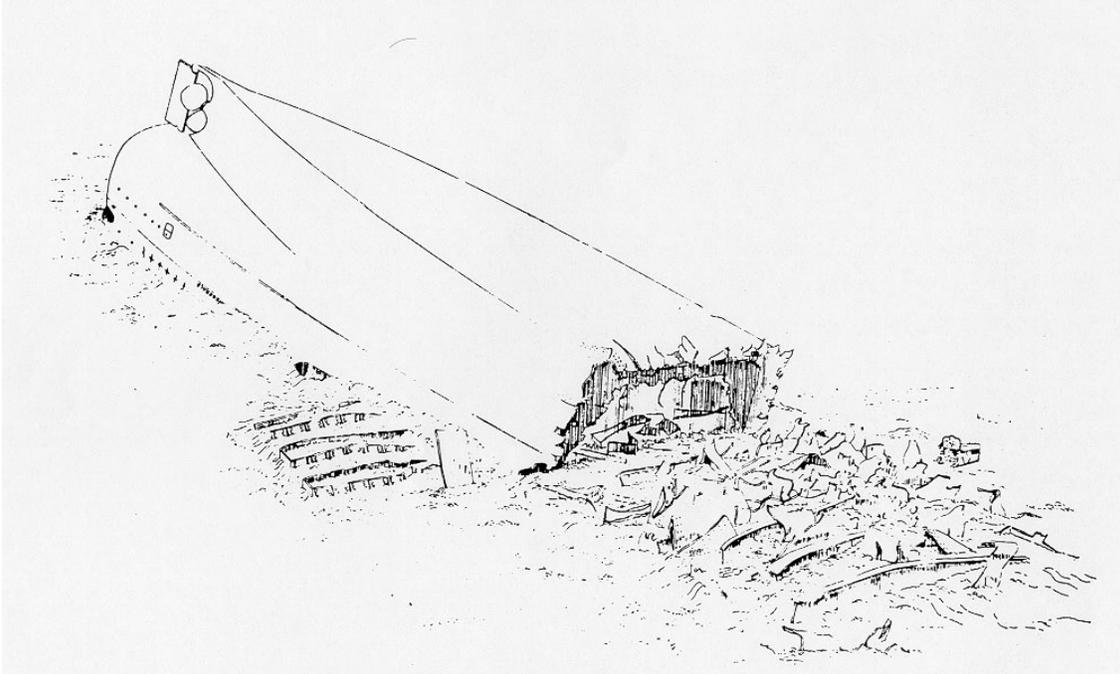
**Figure 9: Stern section of Edmund Fitzgerald Wreck Source: National Transportation Safety Board (1978)**

There is no coating of taconite pellets on top of the largely intact stern which suggests that it may have floated for some minutes before sinking or that it may have contained enough trapped air inside watertight compartments to achieve a relatively slow terminal velocity compared to the taconite pellets.

A number of sources have claimed that the *Fitzgerald* was damaged by running over a “6 fathom shoal”. There is no sign of grounding damage to the exposed stern section, which would be deepest in the water under normal conditions. She left the dock with final drafts of 27 feet, 2 inches forward and 27 feet, 6 inches aft. (NTSB 1978) Note that 6 fathoms is 36 feet, so the *Fitzgerald* would have passed over a “6 fathom shoal” with 8-1/2 feet to spare. A new more precise hydrographic survey of the area traversed by the *Fitzgerald* found that the 6 fathom shoal did not actually exist, but was rather an error on the earlier charts. The Coast Guard report and associated documents prove that there was no shoal water within 3 miles of the track of the *Fitzgerald* and therefore no damage due to grounding. However the popular media continues to push the discredited grounding theory.

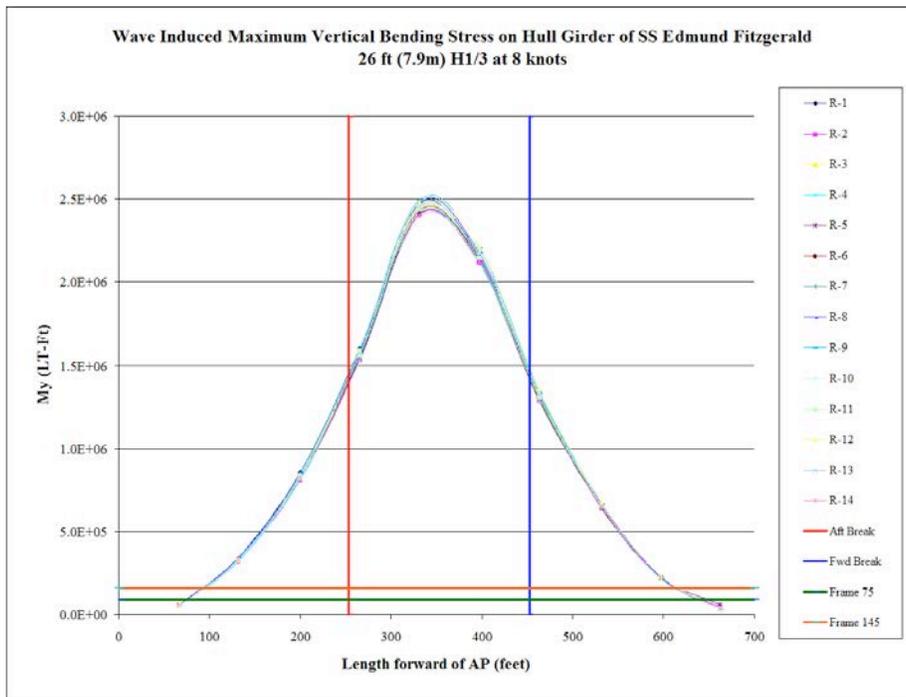
Figure 18: Maximum Wave Induced Vertical Bending Stress.

Figure 18 shows the maximum vertical bending moment along the hull girder from all 14 runs made at 8 knots in 26 ft (7.9m) significant wave height at 9 seconds modal period in a JONSWOP spectrum. The orange and green horizontal lines correspond to the maximum design values at frames 75 and 145. Clearly the vertical bending stresses encountered exceed these design limit values by a large margin. The vertical red and blue lines represent the forward and aft hull fracture locations discovered in the wreck.

Figures 17, 18 and 19 all represent runs in the damage condition where the vessel is listing an average of 7.4 degrees to starboard and is trimming 18 inches (.5m) down by the bow.

Based upon this data, failure of the hull girder in bending amidships cannot be ruled out.

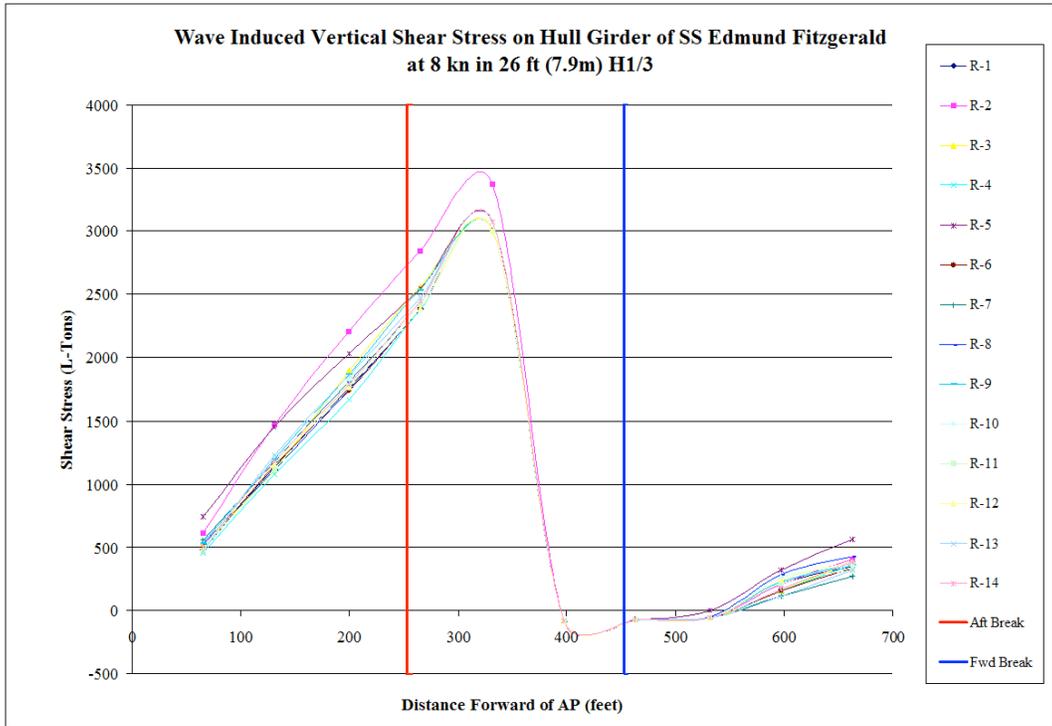
**Figure 19: Maximum Wave Induced Shear Stress.**

Figure 19 shows the  $F_y$  wave induced shear forces on the Hull girder in the same waves. In this case the limiting values do not appear on the graph as they are well outside the maximum range achieved.

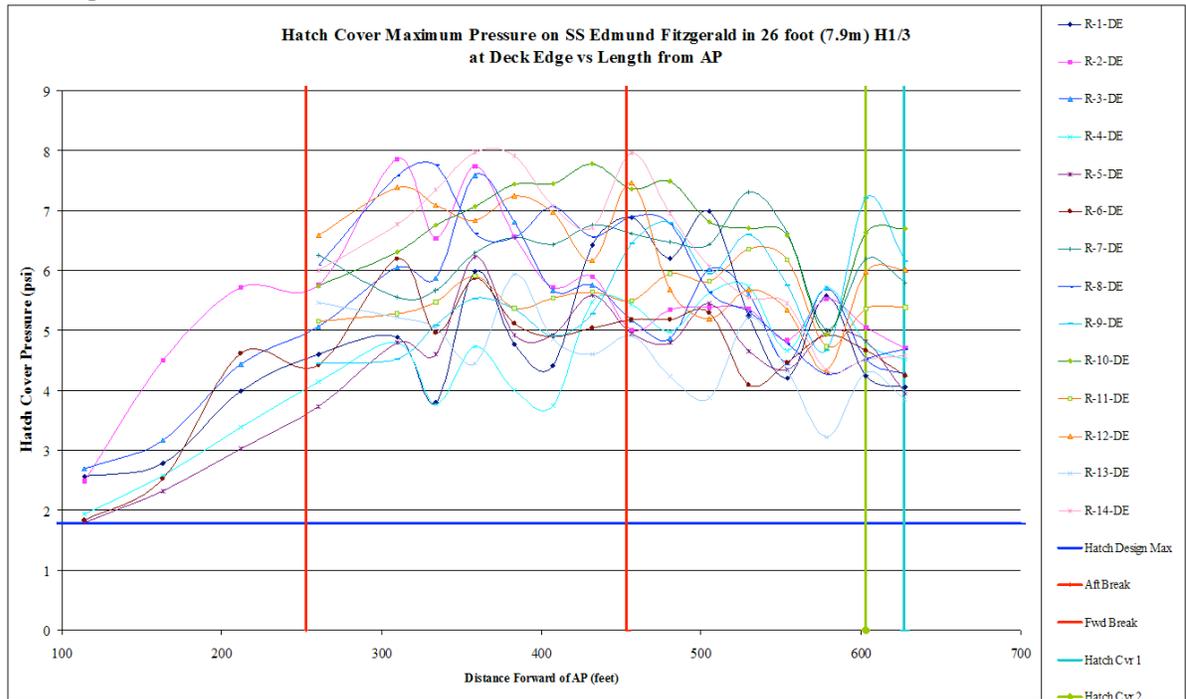
**Figure 21: Maximum Hatch Cover Pressures in 7.9m waves at 8 knots**

The hatch cover design pressure was 4 ft of fresh water or about 1.8 psi

It is fairly obvious that the maximum pressure was 3 to 4 times the design load of 1.78 pounds per square inch, over much of the ships length. The aft most hatch covers were sheltered by the stern house to some degree. The pressures shown represent the hydrostatic head pressures of the green water sweeping a smooth deck. In reality the local pressures would be much more chaotic.

When the waves reached the aft end of the forward house, they would attempt to reflect off it like harbor waves do off a sea wall with a localized doubling in height if the wall is high enough. This doubling in height as the wave reflected off the house right over the forward hatch covers suggests that this may have been causative in the hatch cover failure and eventual downflooding.

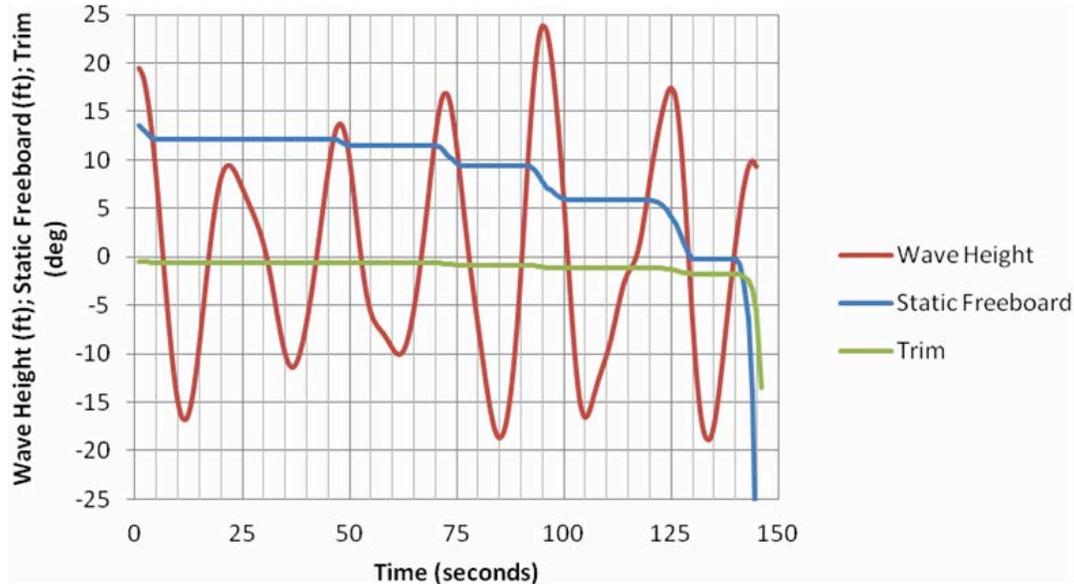
**Figure 23: Summary of Progressive Flooding Model Results**

The results of the progressive flooding model are summarized in the chart shown in Figure 23. In figure 23, the red line indicates the time history of wave height, the blue line is a time history of static freeboard, and the green line is a time history of vessel trim by the bow. Three very important results should be noted based on this graphical representation of the sinking process. The first is the time required for the vessel to sink. The progressive flooding analysis resulted in a hatch-collapse to bottom-impact time of approximately two minutes and twenty-seven seconds. This time is incredibly fast for a vessel the size of the *Fitzgerald*.

In addition to the rapid sinking time, the second result is the observed decrease in freeboard with each wave that exceeds the static freeboard level. The freeboard is seen to

fall in steps to zero as the vessel sinks. Once the freeboard effectively vanishes, the next wave causes the vessel to plunge.

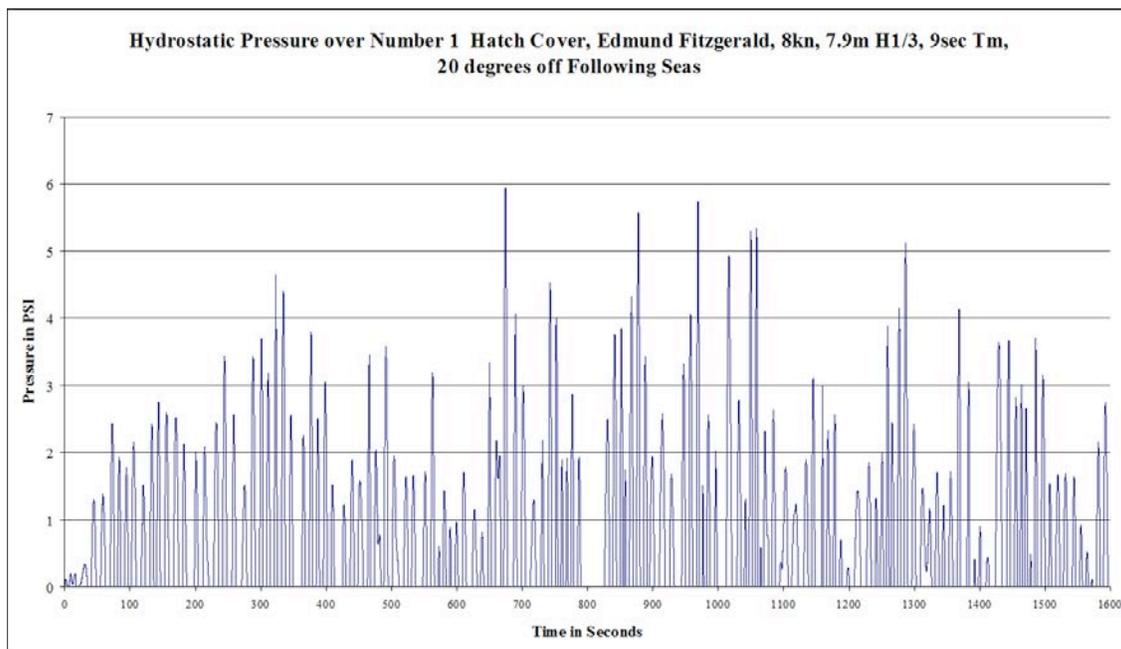
**Figure 25: Example of a Pressure Time Series over Number One Hatch Cover**

The sinking of *Edmund Fitzgerald* occurred because of the convergence of a number of seldom occurring events. November gales were a known risk, but they have not caused sinkings every year, but rather only once in a decade or so. The damage to the vents on the *Fitzgerald* that initiated the failure cascade, did not occur on the *Anderson* or the *Avafors* in that storm, nor was it a common occurrence on vessels in this trade. Waves large enough to produce the damage to the forward house only occur in a few waves out of hundreds. Figure 25 shows a typical green water on deck time history from part of a single run. The pressure only exceeds 5 psi about 6 times in about 128 wave encounters.

The maximum pressures of 10 psi over the forward hatch covers in figure 21 only occur in one out of the 14, 40 minute time series. As explained previously this pressure does not account for the reflection and approximate doubling when the wave hit the back of the house and went up it. However this does not change the fact that these are seldom occurring events at the threshold level of 26 ft (7.9m) significant wave height.
