Highway Accident Report - Multiple
Vehicle Collisions and Fire, Caldecott
Tunnel Near Oakland, California, April 7, 1982

(U.S.) National Transportation Safety Board
Washington, DC

1. Report No. NTSB/HAR-83/01		2. Government Accession No. PB83-916201		3. Recipient's Catalog No.	
4. Title and Subtitle Multiple Vehicle Collisions and Fire Caldecott Tunnel, Near Oakland, California, April 7, 1982.		5. Report Date May 3, 1983		6. Performing Organization Code

**MULTIPLE VEHICLE COLLISIONS AND FIRE
CALDECOTT TUNNEL
NEAR OAKLAND, CALIFORNIA
APRIL 7, 1982**

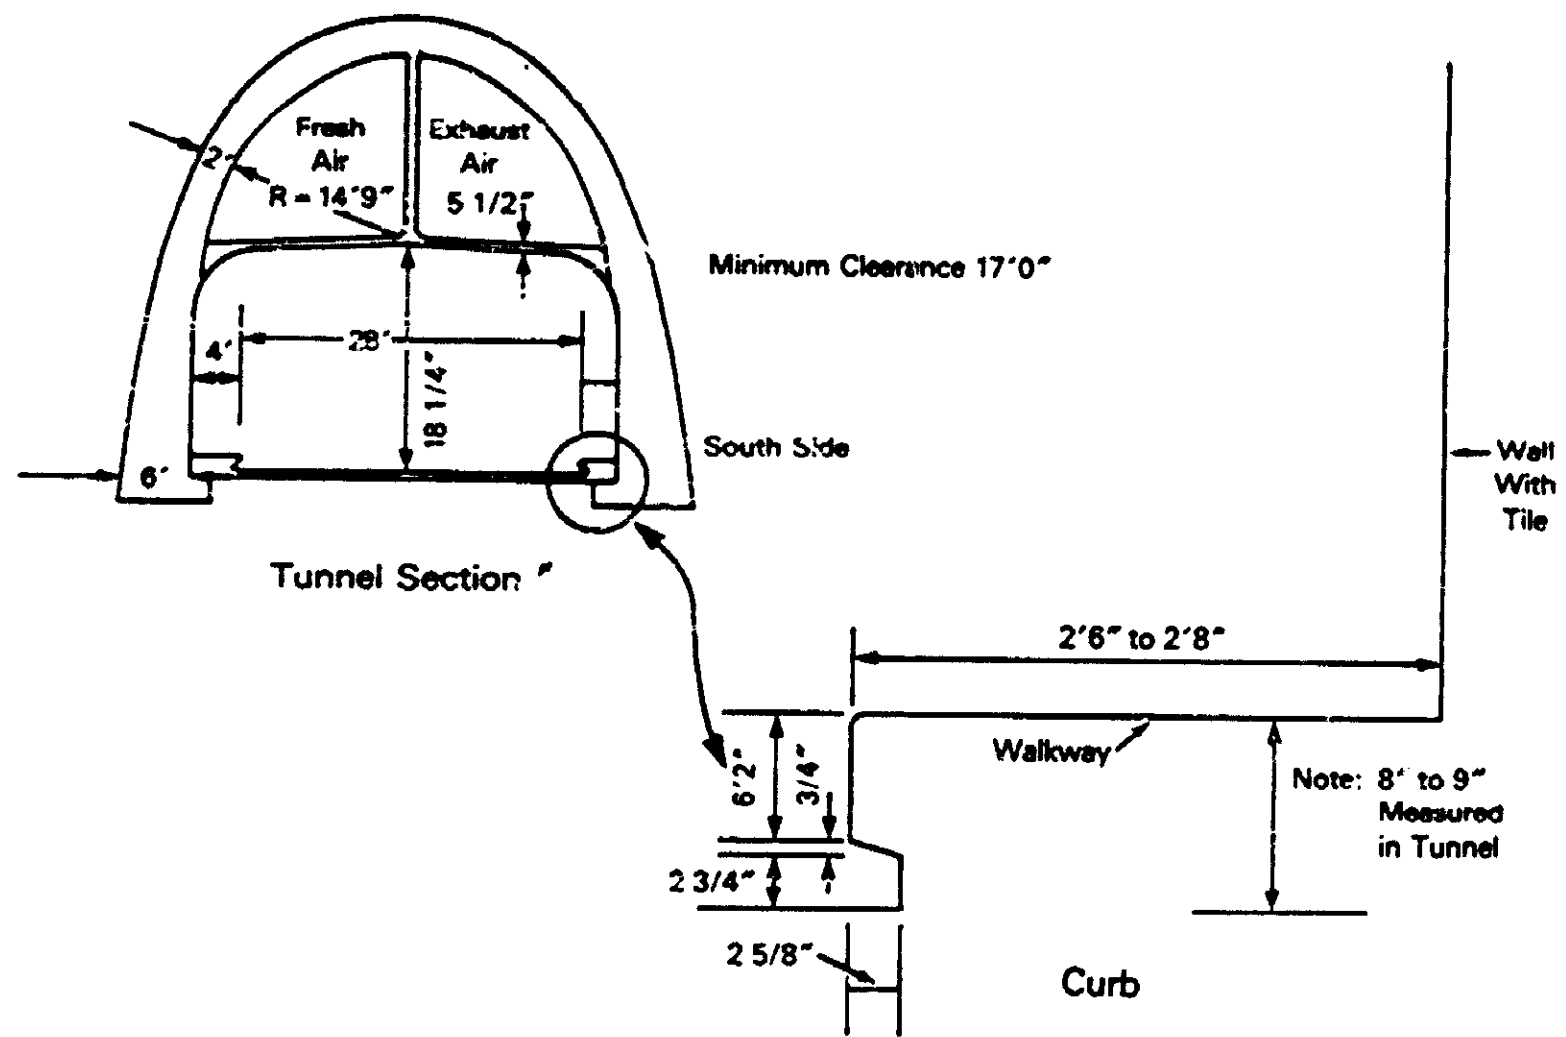
Figure 12.—Cross section of Bore No. 3.

The No. 3 (north) bore (see figure 12) has a two-lane, 28-foot-wide roadway and is 34 feet 6 inches wide between the sidewalls of the bore. There is a 4-foot-wide walkway on the north side and a 2 1/2-foot-wide walkway on the south side. The walkways are 8 to 9 inches above the surface of the roadway. The minimum vertical clearance above the roadway is 17 feet with a maximum clearance of 18 feet 4 inches along the bore centerline.
