SANDIA REPORT

SAND88-2902 • UC-70

Analysis of the Accidental Explosion at Pepcon, Henderson, Nevada, May 4, 1988

Jack W. Reed

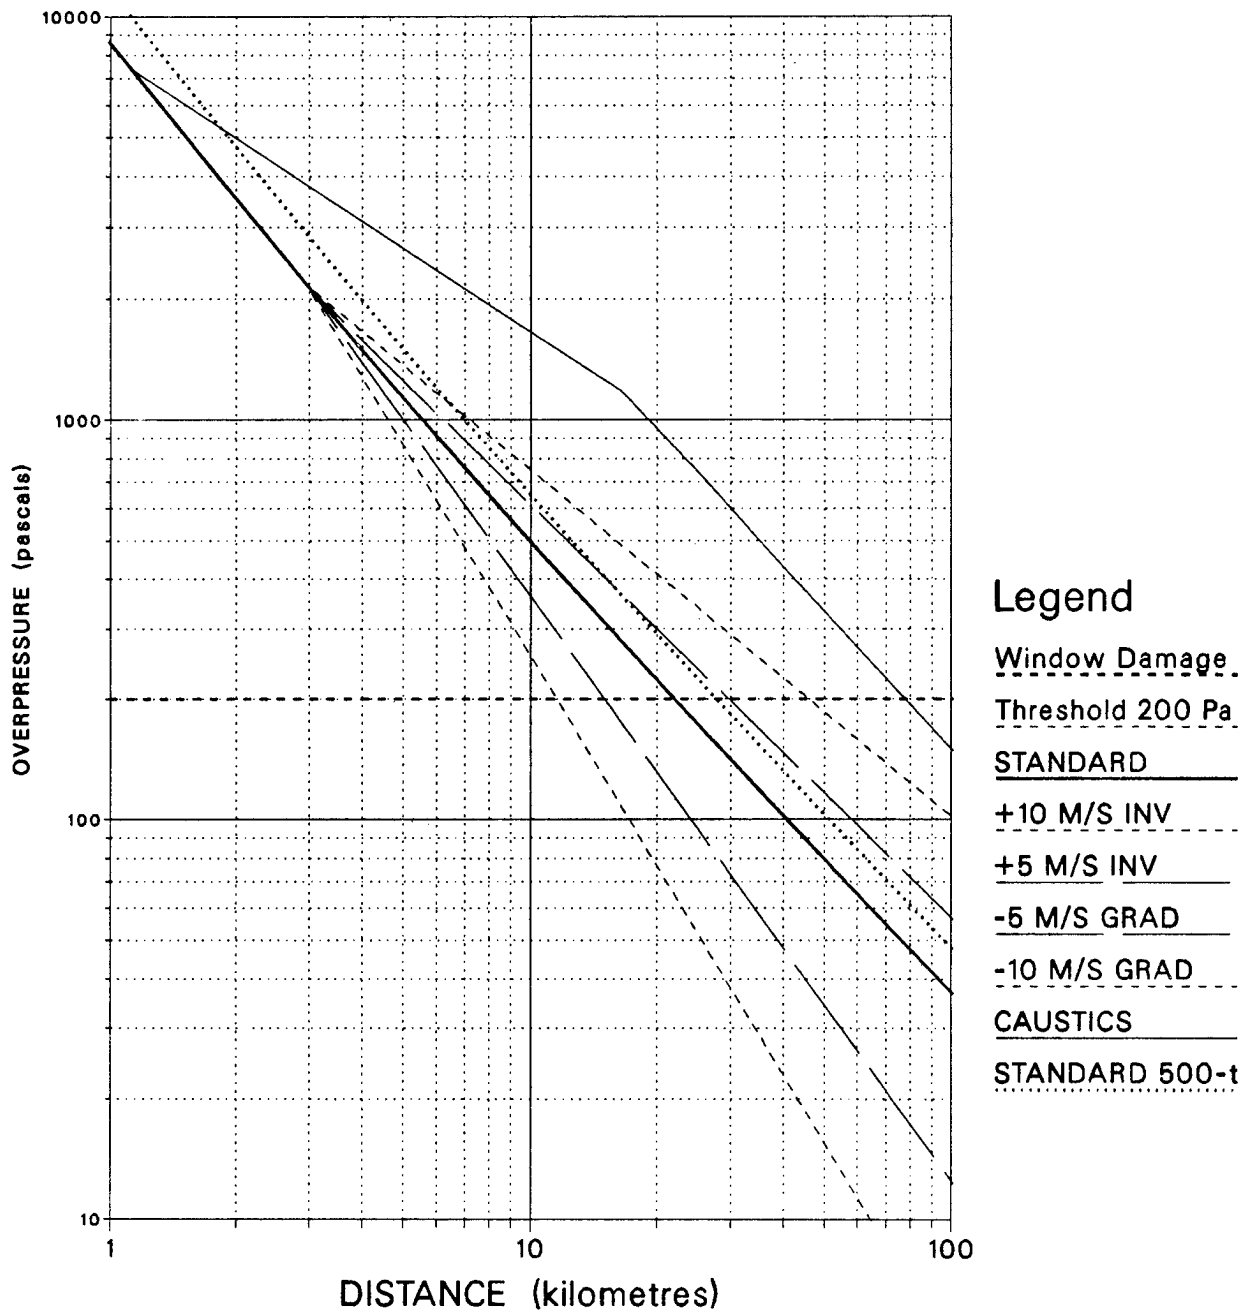
By comparison it appeared that Arroyo Grande Estates had experienced something near these two test conditions, 2.8- to 3.5-kPa overpressure. From Figure 3 this would indicate a source explosion close to the Standard curve for a 1-kt NE spherical free-air burst. This airblast could be duplicated by 250-t HE surface burst. Much later, off-the-record conversations with other accident investigators indicated that close-in damage to relatively ideal structural elements led to a conclusion that 500-t HE seemed a more appropriate equivalent yield. Considering the 26% greater overpressure-distances from a doubled yield and the relatively large scatter of damage interpretations, it is impossible to argue over this factor of 2.

Figure 4. Airblast overpressure versus distance curves for 1-kt NE free-air burst (or 250-ton TNT surface burst), at 579 m MSL altitude, 94.1 kPa ambient pressure.

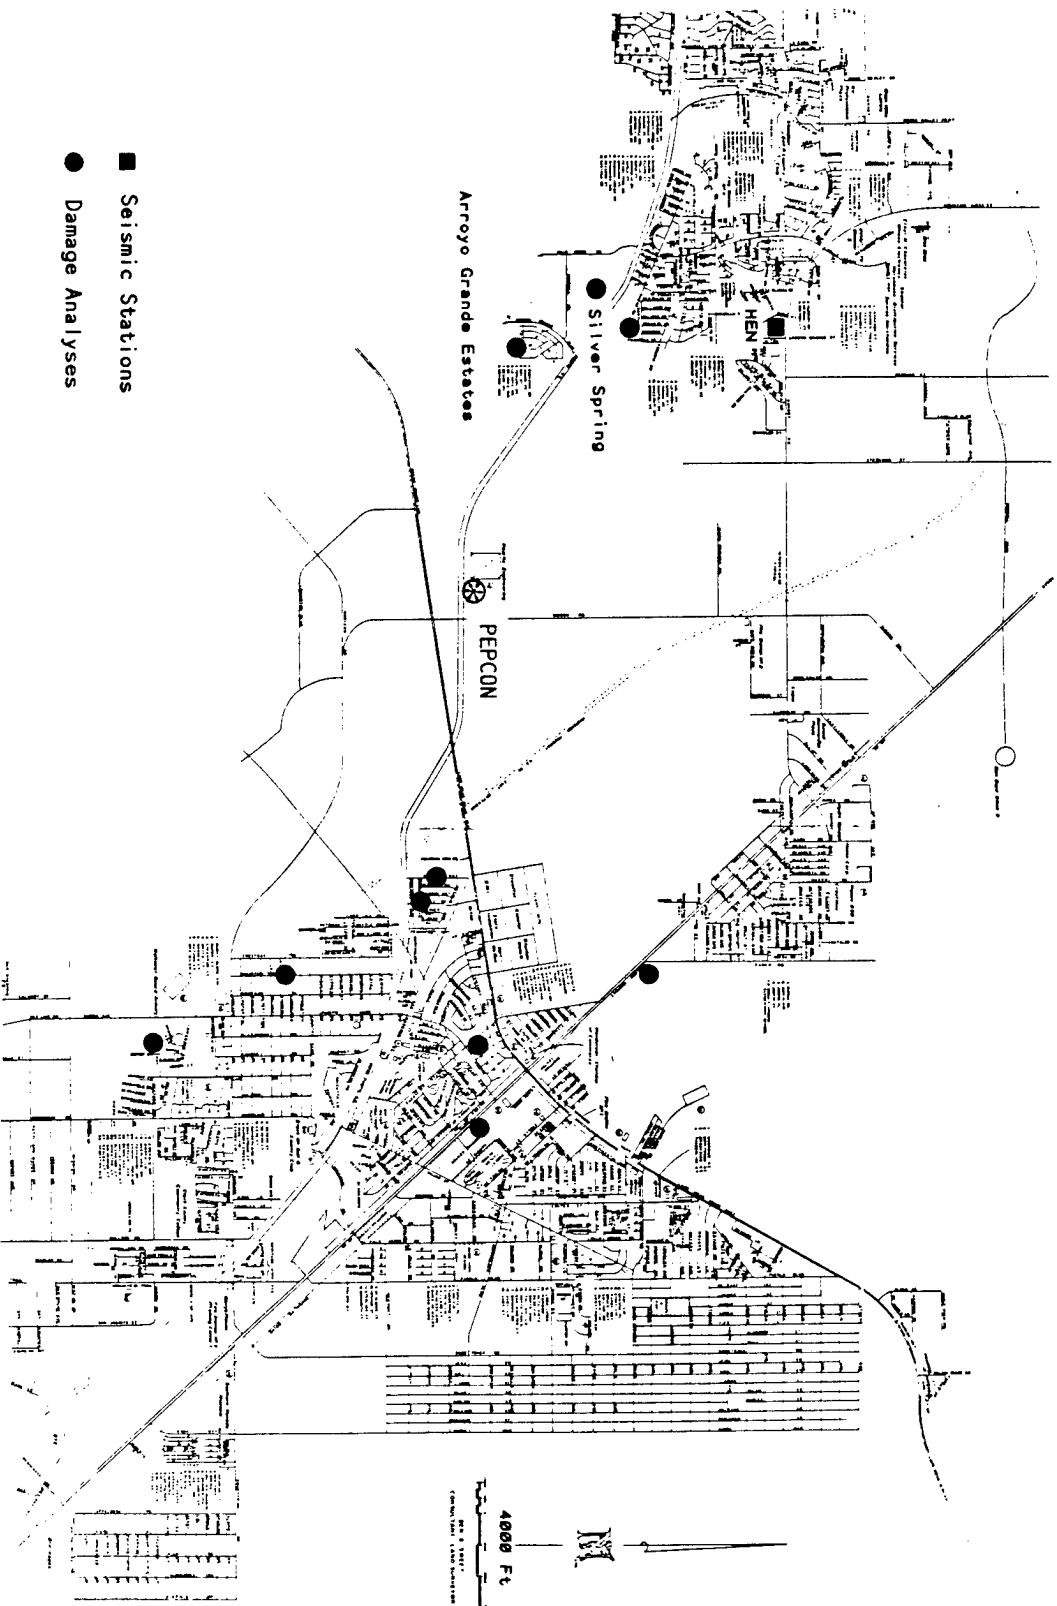
Figure 9. Street map of Henderson, Nevada, (from Henderson Chamber of Commerce), with explosion site and locations for damage analyses.

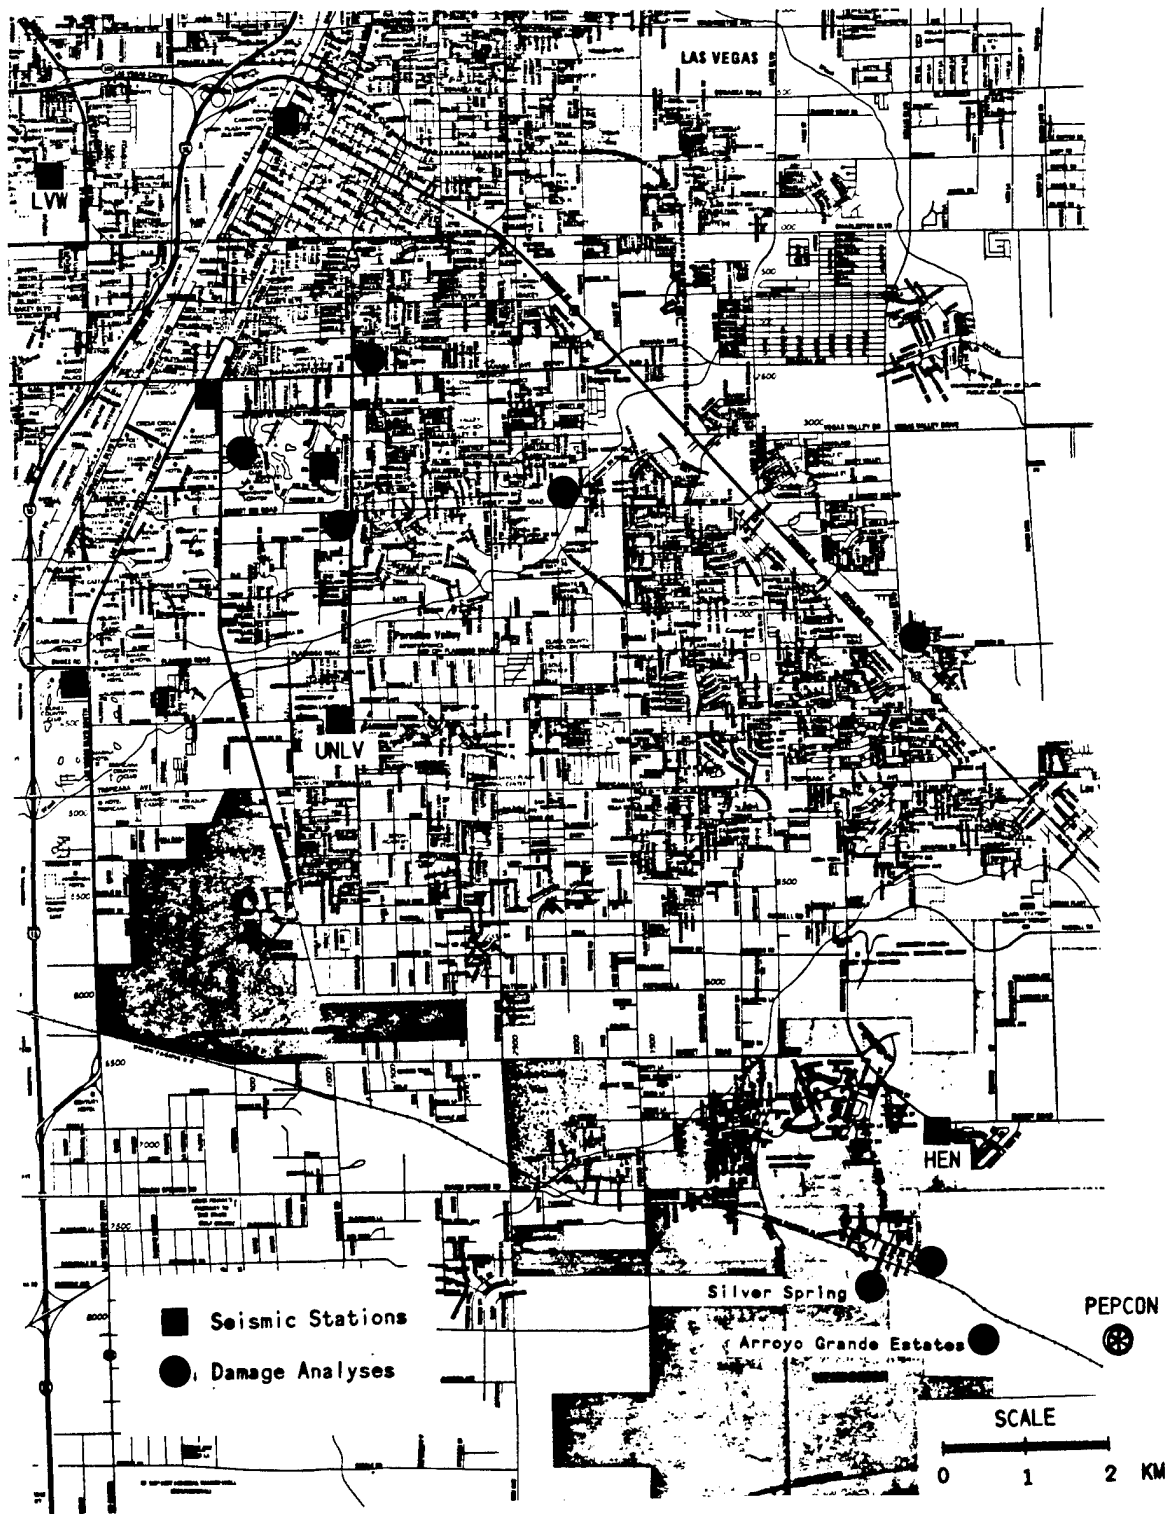
J. L. Woodruff, of URS/John A. Blume & Associates, seismic consultants to DOE-NVO, lives near Boulder Highway and Flamingo Road, Las Vegas, about 9 km from the blast according to the Las Vegas map in Figure 11. He reported that about one-third of his neighbors had window damage. This was interpreted as 330-Pa overpressure, near the -10 m/s gradient curve and clearly lacking any strong enhancement in spite of their generally downwind direction. They were probably in the "silent zone" between focused caustic arcs.

Continuous recordings are made at Station S-2, at the University of Nevada Las Vegas (UNLV) Chemistry Building, off Maryland Parkway and south of Flamingo Road, and at the Las Vegas water pumping plant, S-8, north of Charleston Avenue in northwest Las Vegas, as shown in Figure 11. It had been hoped that these recordings could be used to determine times for the various reported explosions, but it appears that only the first and third explosion were strong enough to cause a readable oscillation. Some recorders were not even triggered to operate by ground motion arriving from the first explosion wave, and only recorded the airblast wave. Clear audibility of only two blasts was also reported (R. C. Bass, SNLA-7111, pers. comm., 1988) from a point on Sahara Boulevard, between Paradise Road and Maryland Parkway. On the other hand, as previously cited, a video-camera recording gave both video and audio indications of a moderately large explosion about one second before the final, large blast.

Figure 11. Street map of Las Vegas, Nevada (from Rand McNally), with explosion site and locations for damage analyses.
