# **A Forensic Investigation Of The Breakup And Sinking Of The Great Lakes Iron Ore Carrier *Edmund Fitzgerald*, November 10th 1975, Using Modern Naval Architecture Tools And Techniques**

**Sean Kery, CSC Advanced Marine Center, Washington, DC  
Ben Fisher, SAFE Boats International, Bremerton, Washington**

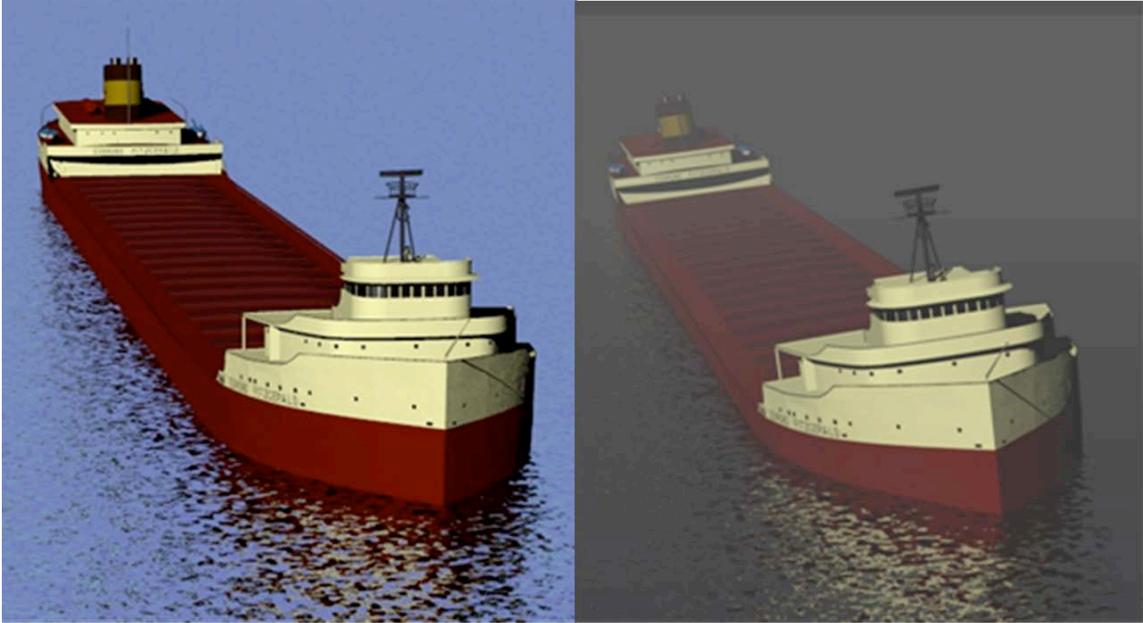
**Figure 13. Illustration of Intact and Damaged Conditions**

The effect of the list on the vessel is best shown visually. Figure 12 is a comparison of the intact and damaged conditions in still water. Figure 15 is a representation of the initial condition for the progressive flooding, including the wave conditions present at the time hatch cover Number 1 presumably collapsed.

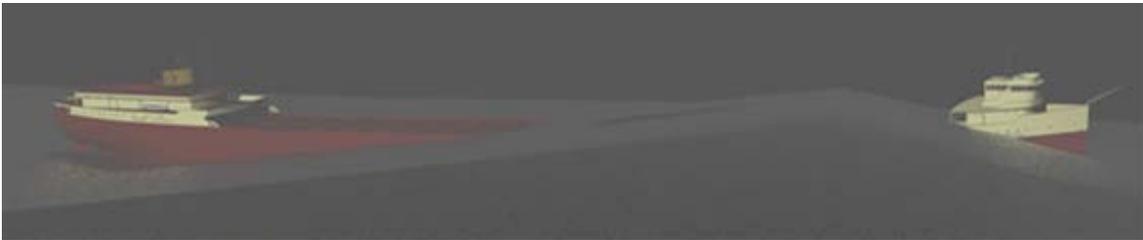
**Figure 14. Damaged Condition In Waves**

Figure 14 demonstrates the severity of the wave conditions present at the time of the sinking.

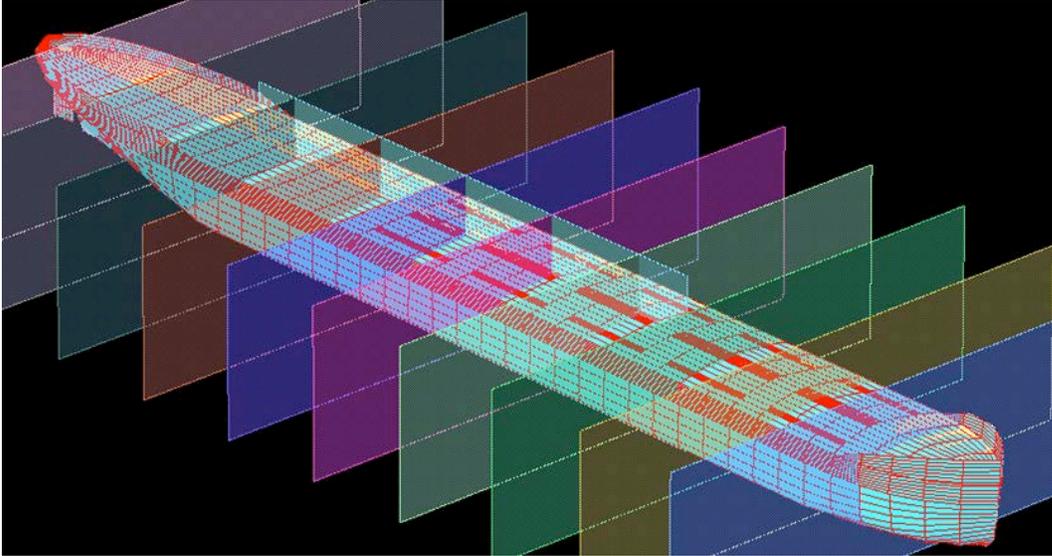
**Figure 16: Cut Planes Used to Develop Wave Induced Hogging and Sagging Moments**

Later the cut planes were increased in number, figure 16, to show the distribution at ten locations along the entire hull girder. The eleventh location in table 7 is a XZ longitudinal + vertical plane, perpendicular to the other ten YZ Transverse + vertical plane cuts.

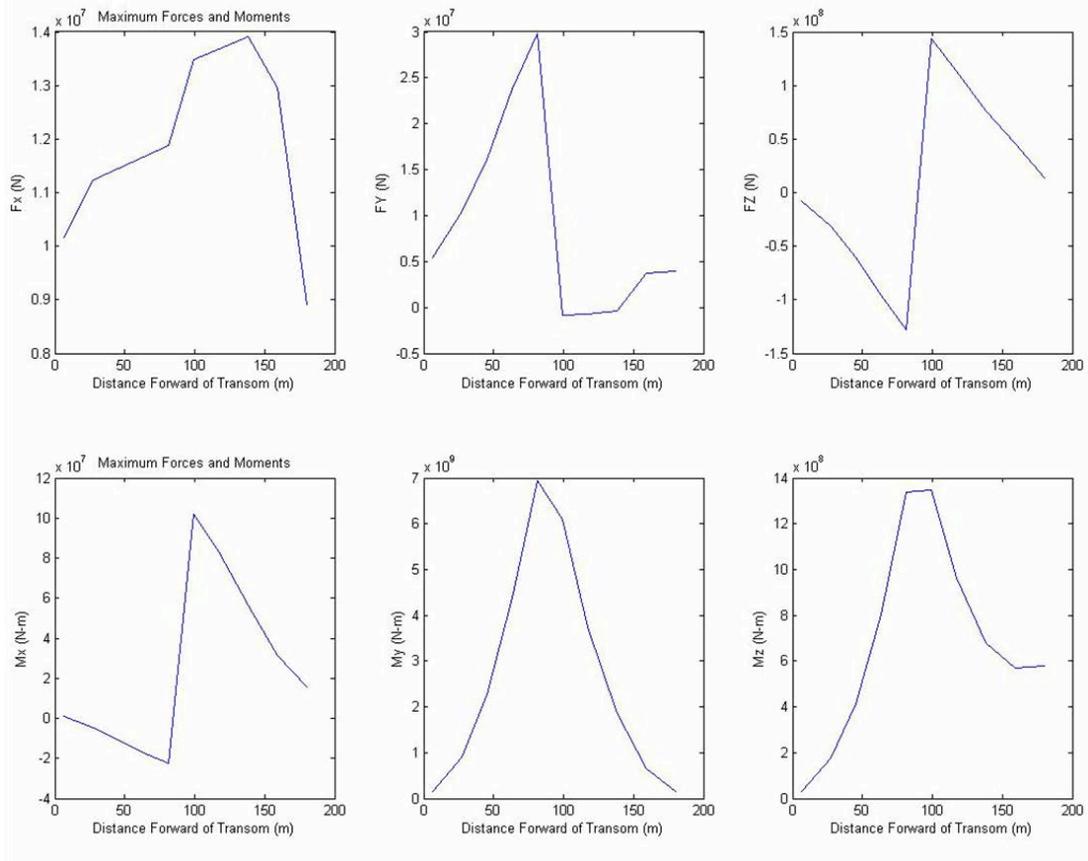
Figure 17: Maximum Shear Forces & Bending Moments in 6 DOF from Typical Run

Figures 17, 18 and 19 all represent runs in the damage condition where the vessel is listing an average of 7.4 degrees to starboard and is trimming 18 inches (.5m) down by the bow.

Based upon this data, failure of the hull girder in bending amidships cannot be ruled out.

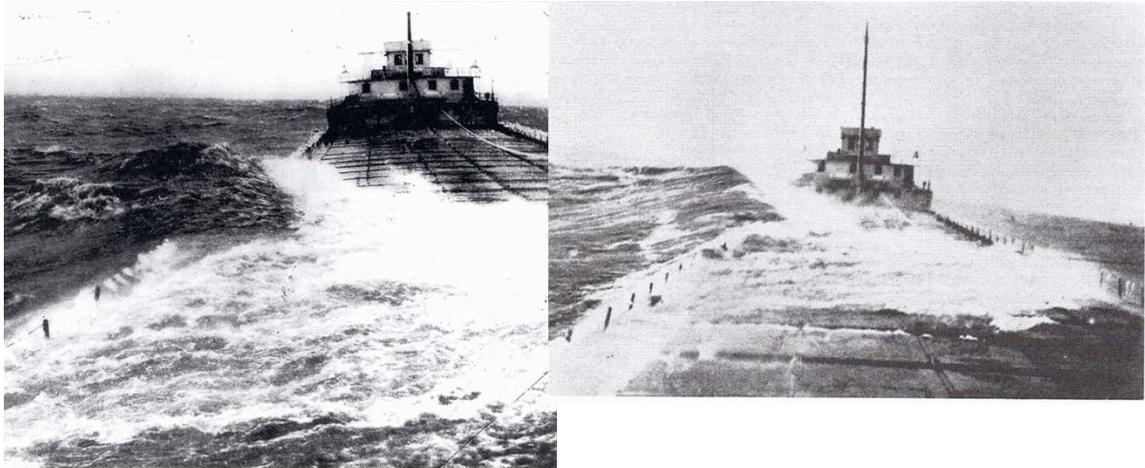
**Figure 20: Two Instances of Green Water on Deck of Great Lakes Iron Ore Carrier, (Unknown?)**

The unknown vessel in figure 20 survived the storm to get these pictures published whereas some others did not. The window configuration on the back of the forward house rules out the *Fitzgerald*. The first 19 hatch cover locations were modeled with a

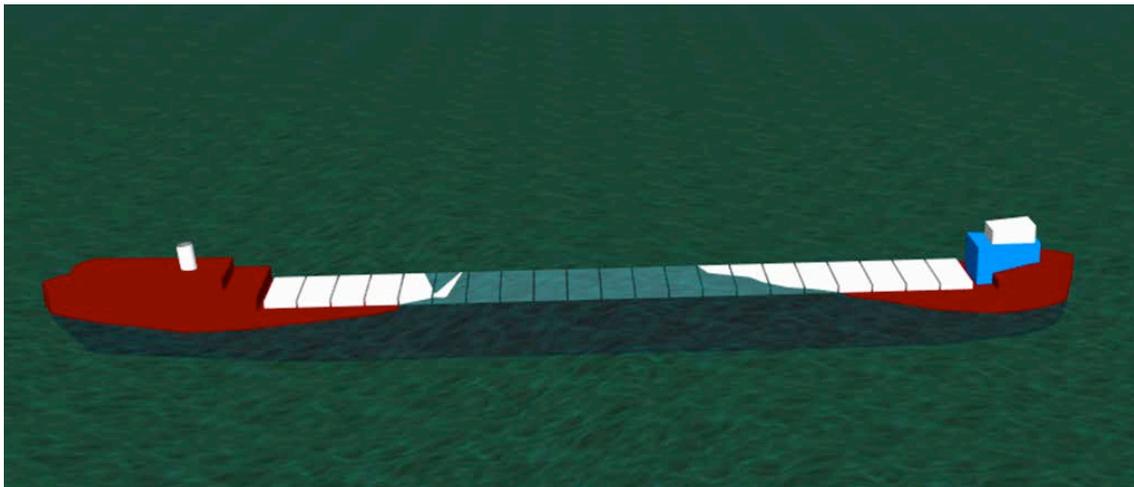
**Figure 22: Orcaflex Visualization Model Showing Extent of Green Water on Deck**

The Orcaflex model was used to visualize the motions and the spread of green water on deck. Unfortunately the graphics don't show the wave steepness.
